# Home Inspection Report

■■■■■■■■■■ ■■■■■■■■■■  
Garfield , New Jersey 07026

Report Number : 07-8677

Inspection Date: July 14 , 2015  
Time : 4:00 PM

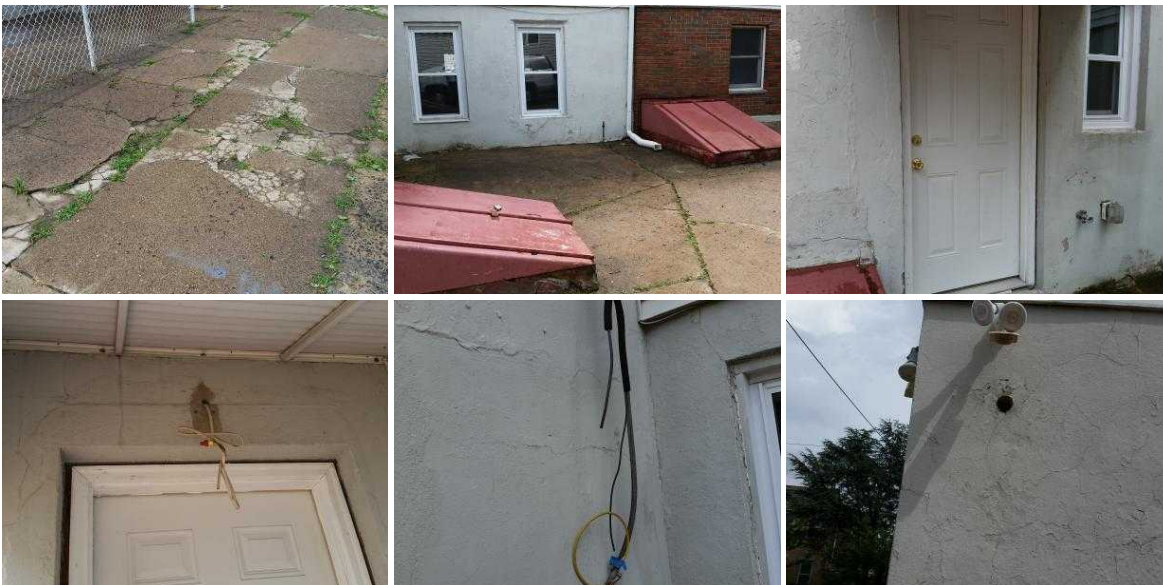
- Defective**                      City Sidewalk: Masonry - Deteriorating and damaged. A tripping hazard is present and not safe.
- Defective**                      Front Walkway: Masonry - Replace walkway and suggested that some type of grading be installed for both esthetics and help with water.
- Defective**                      Front Entrance: Masonry - The steps are uneven. The steps lead directly into the home and a platform of some sort should have been installed.
- Defective**                      Utility Entrance: Masonry - Damaged. The rear added room has exposed wires at both front and rear has hanging cables and freon lines that they too should be removed and birds are nesting in the bathroom vent.

Acceptable	Walkway: Masonry - the left side of the building has what appears to be a fairly new walkway place on top of the old walk. The basement dryer hood is damaged.
Defective	Patio: Masonry - Replace patio. The patio is pitched towards the building and flashing cement is noted against the building.

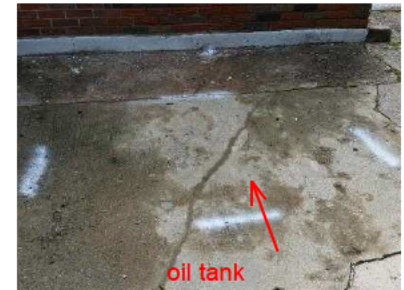
Defective	Landscaping: Add topsoil, mulch and shrubs - almost all the property is covered with concrete and water or water runoff will be diverted towards the street and home. The front basement is wet and water noted on the floor, indicating a problem with water. The right side neighbor is asking for the rear building to have its gutters and leaders to be diverted towards the street rather than his property.
Acceptable	Grading : Minor slope
Marginal	Hose Bibs: Gate - Valves are not operated as part of this inspection, any reference to any valve inspected is visual only unless otherwise noted. The valves are the older style and replacement recommended. The valves are not freeze protection, especially the rear building has a very loose hose bib.
Acceptable	Fences: Chain link
Marginal	Walls: Masonry - Some cracking noted.
Defective	Oil Tank: Suspected previous oil tank. It is recommended that a search for a buried oil tank be conducted.

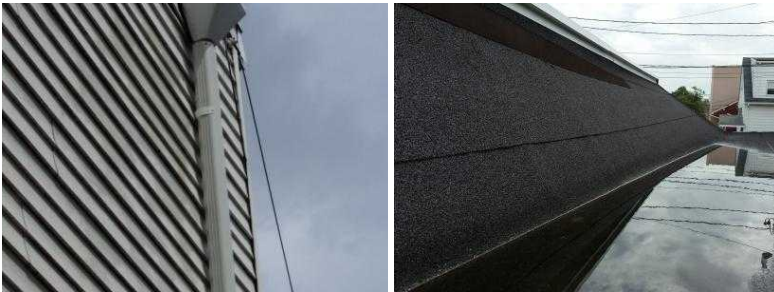
Acceptable	Gutters: Aluminum - The building is equipped with built-in gutters. These are common of these older buildings, but during heavy rains the gutters will overflow. The gutters are essentially extensions of the roof framing with water ways built-in to the roof surface over the edges. The gutter channel may be lined with asphalt roll roofing or some other type the of impermeable material. The channels require more attention than the typical aluminum gutter system.
Marginal	Gutters: Hopper - the added room roof is a mineral roof and the roof is not pitched to wards the side hopper and water is lying on the roof and will only dryout the roof and cause leaks.
Marginal	Downspouts: Aluminum - The downspouts discharge too close to the foundation and should be extended.

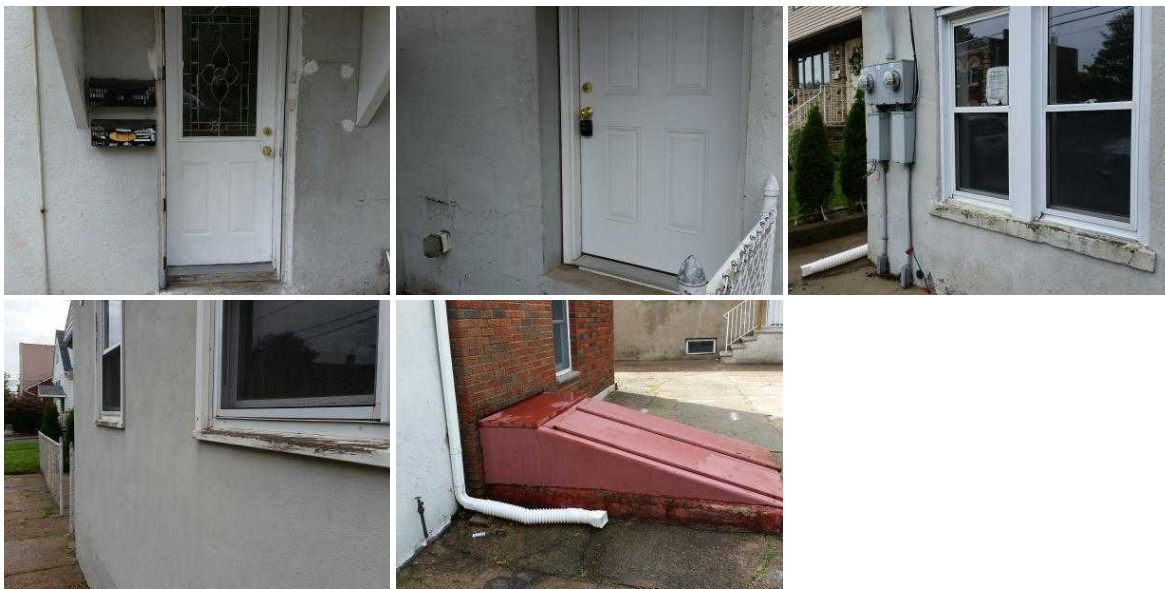
Marginal	Entrance Door: Metal, Metal with glass - the doors have quite few dents and show poorly.
Defective	Utility Door: Metal - Bilco doors noted and both doors are rusting and corroding and allowing water to seep into each basement. The basement stairs are very slippery because of the water.
Defective	Windows: Double hung - Double glazed, and the drip edging, sillplates are all in need of modifications. The front right side windows have only plaster and the cement is damaged, thus water seeping into the home. The right side windows egress onto the roof above the added room and a child can easily walk on the roof and is a concern. The windows may require security or safety bars.
Defective	Base Windows: the basement windows have been covered and the both basement are very wet and the owner is using a dehumidifier, but still the water is present and will only seep into the home and can cause health problems. The added room basement is very poor and mold is noted on the framing indicating a potential problem.

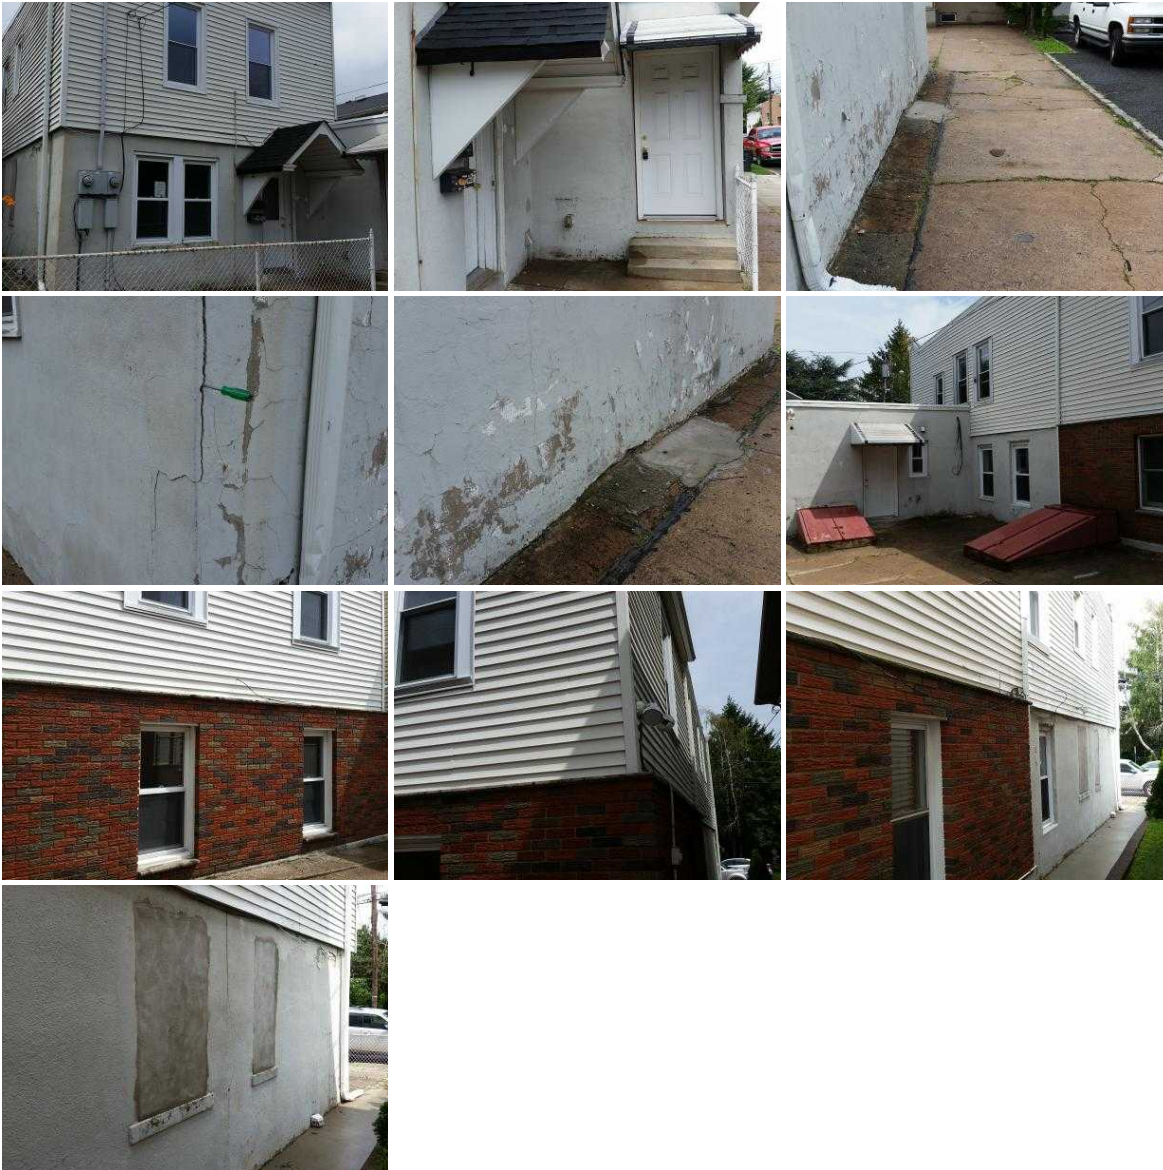
- Defective Material: Masonry - The masonry siding is in poor condition on the front building. The surface is failing, cracking, damaged and should be replaced. The left side of the building has stucco and the front windows have been covered and the opening very noticeable and shows poorly.
- Marginal Material: Vinyl siding - The siding has appears to have been placed over another type of siding, thus the siding is not flush or plumb. The siding is touching the lower brick work and the brick work does not have flashing.
- Marginal Material: Brick veneer - In order to drain any water collected on the flashing, weep holes must be provided above flashing at all flashing locations. Weep holes should be provided in the outside wythe or vertical section of masonry walls at a maximum spacing of about 33 inches on center. Weep holes shall not be

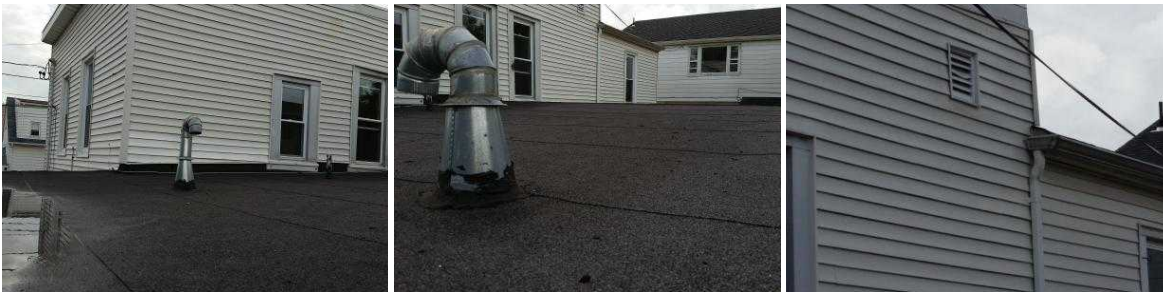
The roof has pooling water. Water staining is noted on the floor in the unit beneath this pooling water. The seams are open and the roof at not be properly installed. A licensed roofer should be retained to further evaluate the roof and estimate for repairs. Tye aluminum capping to the parapet wall appears to be incorrect.

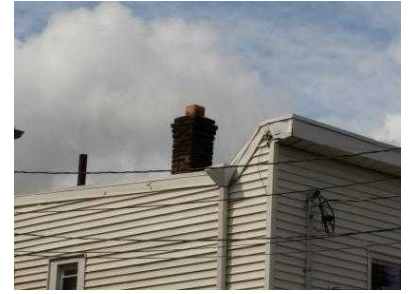
Marginal	Material: Masonry - The chimney could only be partially viewed due to height. The viewable portions are in need of repairs and a licensed mason should be retained for estimates and repairs. The old heating system was an oil fired unit and the chimney should have conform to its requirements. The flue pipe penetrates the chimney and the chimney does not conform and is unsafe and should be revised.
Defective	Flue/Flue Cap: No cap.
Not Inspected	Flashing: Flashing tar is a temporary remedy and should not be used. The tar traps moisture in the structure of the chimney causing deterioration.

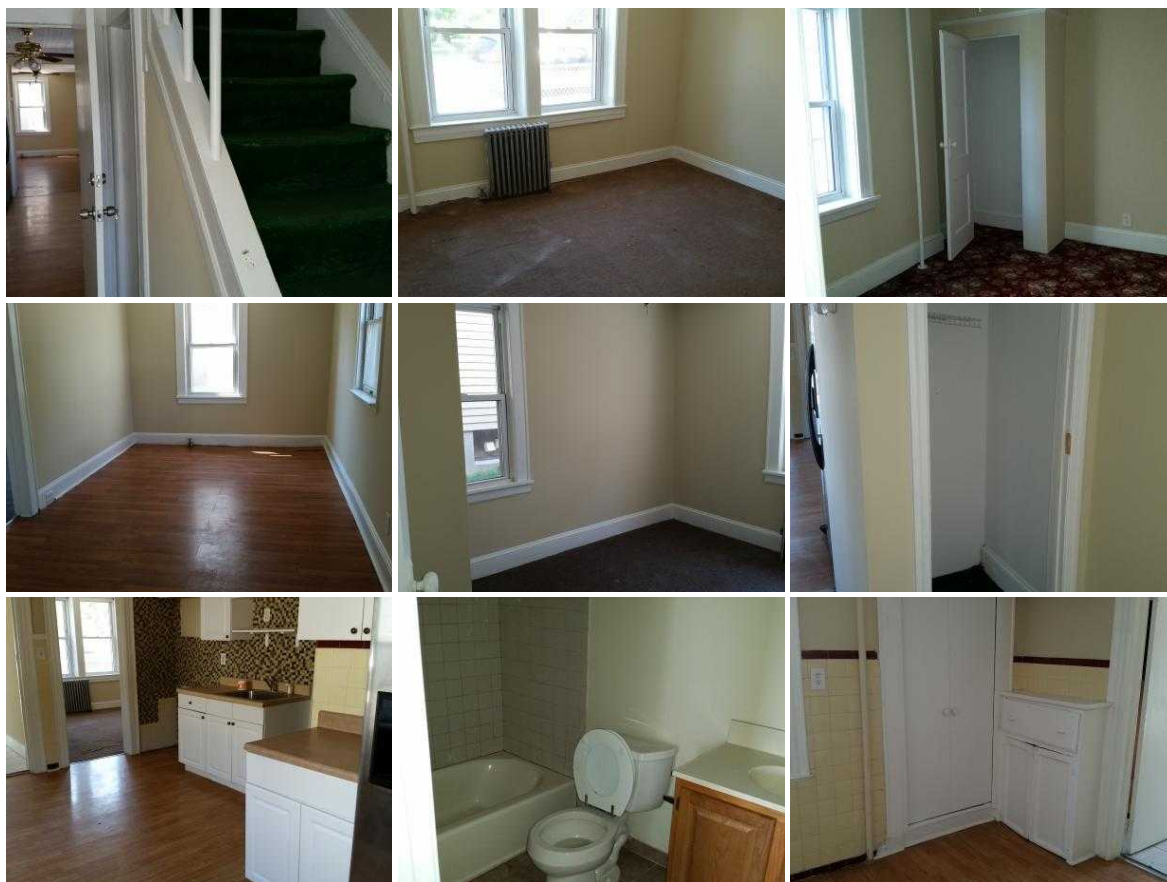
Marginal Floor: Laminate - Poor installation  
 Marginal Walls/Ceiling: Paint - The molding throughout the home and the other home is very old and the trim work may contain a lead base paint. The city health department may perform a lead test and the inspectors should be addressed.  
 Marginal Doors: Wood - Missing closet door.  
 Acceptable Windows: Double hung - Double glazed  
 Marginal Electrical: 120 volts - The electrical system in some rooms are limited and most likely need additional outlets.  
 Defective HVAC: No Heat missing radiator

Defective Floor: Wood, substrate - Water staining noted on floor and subflooring very soft due to the water in the basement.  
 Marginal Walls/Ceiling: Paint - Air conditioning lines abandoned in this room. Sink connections are noted. Laundry connections also present.  
 Acceptable Doors: Wood, Metal  
 Acceptable Windows: Double hung - Double glazed.  
 Marginal Electrical: 120 volts - Cover plates noted. Missing outlets limited outlets.  
 Defective HVAC: No heat.

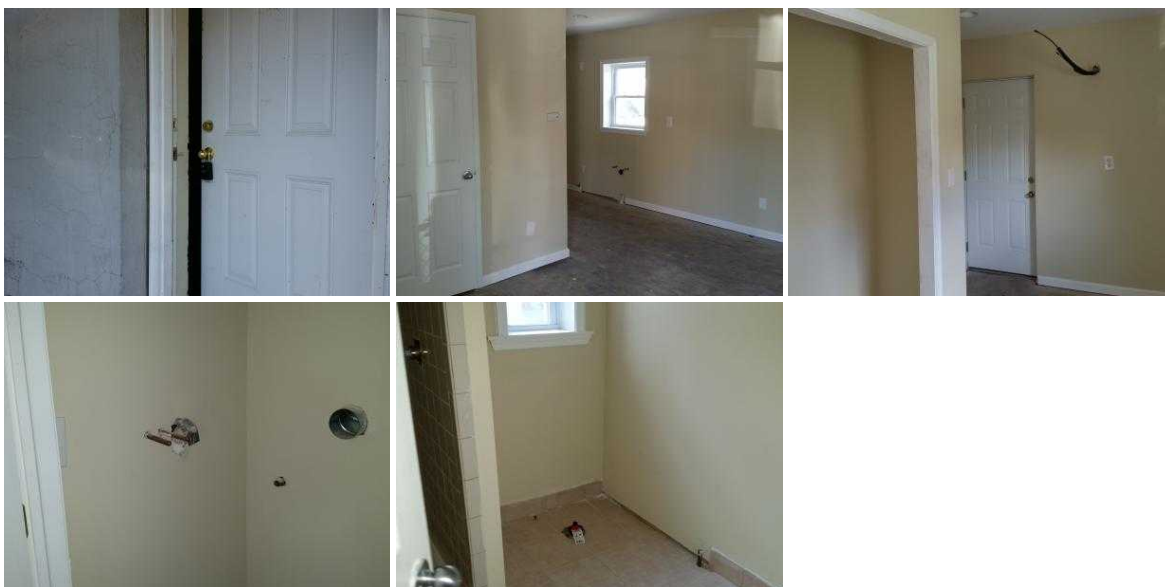
Acceptable	Doors: Wood
Acceptable	Windows: Double hung - Double glazed
Acceptable	Heat Source: Radiator
Acceptable	Cabinets: Laminate and composite materials
Marginal	Counter Tops: Laminate and composite materials - Damaged.
Acceptable	Sink: Stainless Steel
Acceptable	Electrical: 120 volts, 120 volt GFCI
Acceptable	Plumbing/Fixtures: PVC and metal
Marginal	Cooking Appliances: Missing - Remember, all stoves, book cases, and furniture should have anti tip anchors.
Acceptable	Ventilator: Windows

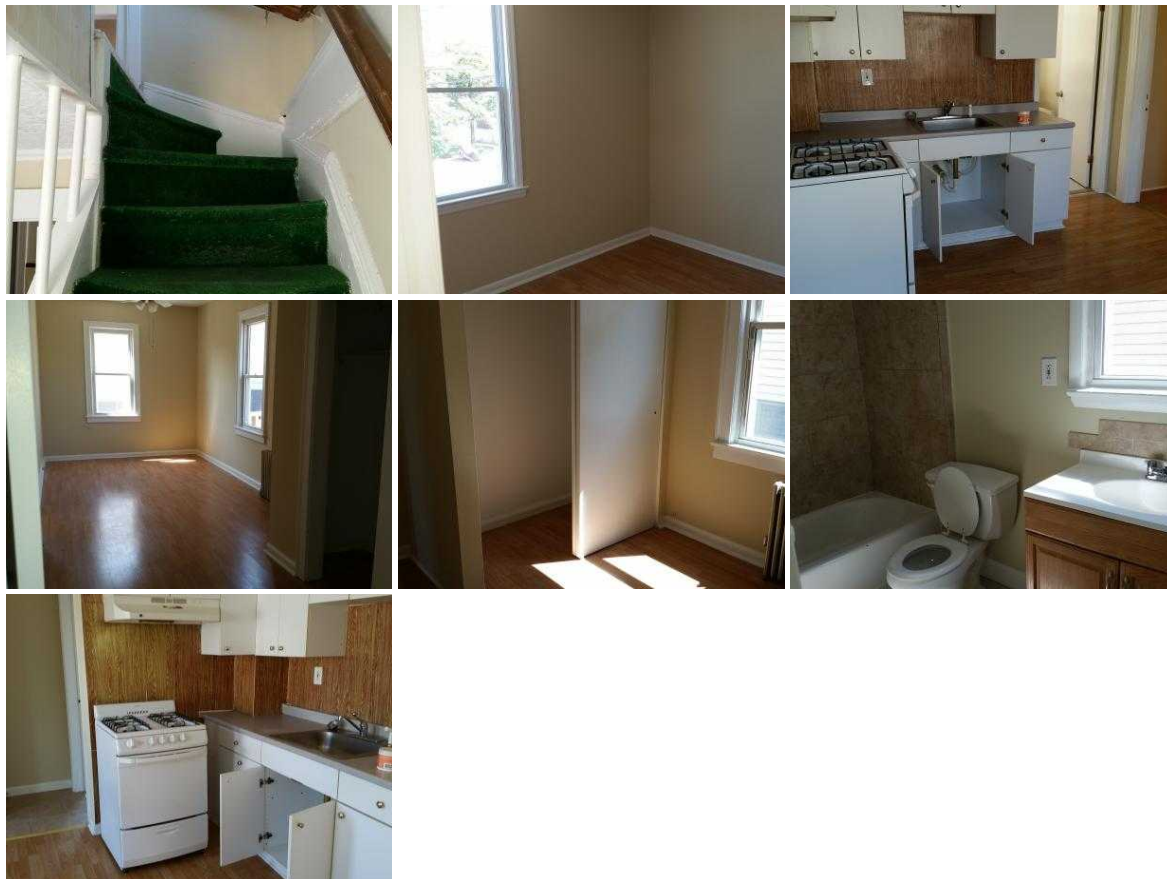
Marginal	Floor: Laminate - Damaged seams.
Acceptable	Walls/Ceiling: Paint
Acceptable	Doors: Wood
Defective	Windows: Double hung - Double glazed, broken glass.
Acceptable	Electrical: 120 volts
Acceptable	HVAC: Radiator

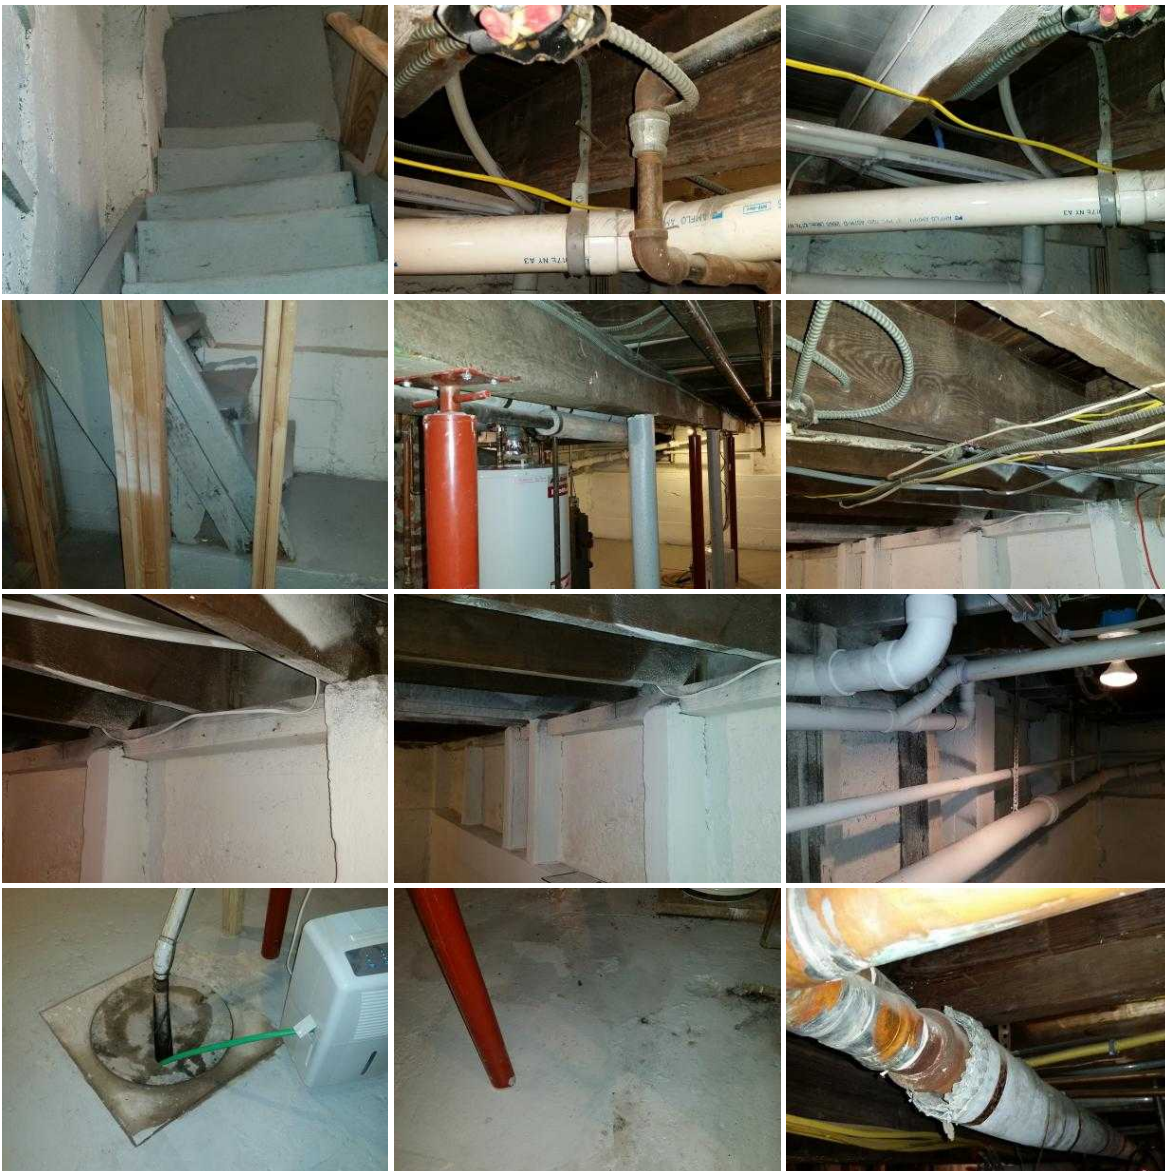
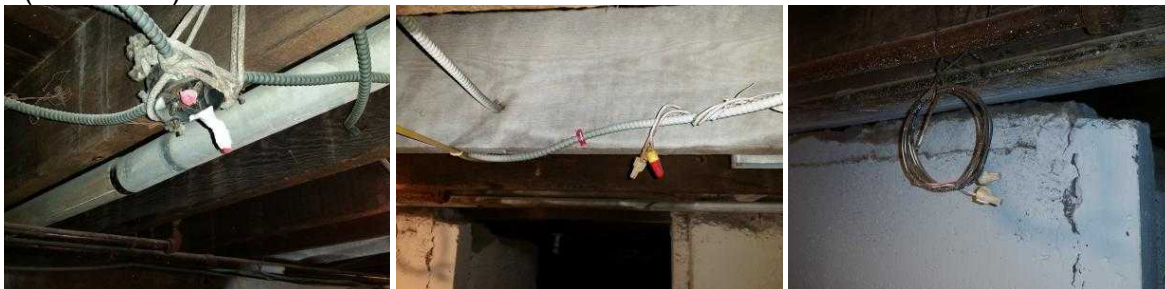
Marginal	Stairs: Wood stairs with handrails - , but very low height and hard to maneuver because the stairs do not conform
Acceptable	Foundation: Poured masonry
Acceptable	Cracks: Stress cracks are present and the foundation should be monitored over time.
Acceptable	Floor / Slab: Painted masonry
Marginal	Girder: Solid member - the main girder is a single piece and is very old and the member has sagged. The member has lally columns for vertical supports and added temporary posts added for more support, but the telescopic members are temporary and not permanent.
Marginal	Joists / Truss: 2x10 - the joists at the foundation walls have been modified with with masonry piers with a horizontal support. This might have been added because the floor joists are embedded to the outer walls and may or most likely develop wood rot. The horizontal member should not have been used rather than use a two or three piece pressure treated member.

Acceptable	Subflooring: Plywood
Marginal	Posts / Piers: Lally columns, Telescopic columns - The girder is also being supported by a temporary post, commonly called an adjustable screws column. These members might have been used for leveling the framing, but once the framing is level, the jack should have been replaced replaced with permanent lally column. It is recommended that a competent repair firm be contacted to further assess and correct this major defect.
Defective	Ventilation: None - Inadequate ventilation and a contractor is recommended to evaluate and estimate repairs
Defective	Electrical: 120 volts - quite a few loose, exposed and not terminated wires and open junction boxes that are not safe.
Marginal	Sump Pump: Float - Sump pump not connected to dedicated GFCI circuit. The sump pump does not have a battery back up system and is a recommended means in case of power loose. The system does not appear to be correct because there is water lying on the floor. If there is crushed stones underneath the floor, water should not be on the floor, thus the system will need to be modified with maybe a perimeter drain. The water in the basement will also need to be identified and a de-watering company will need to be retained.

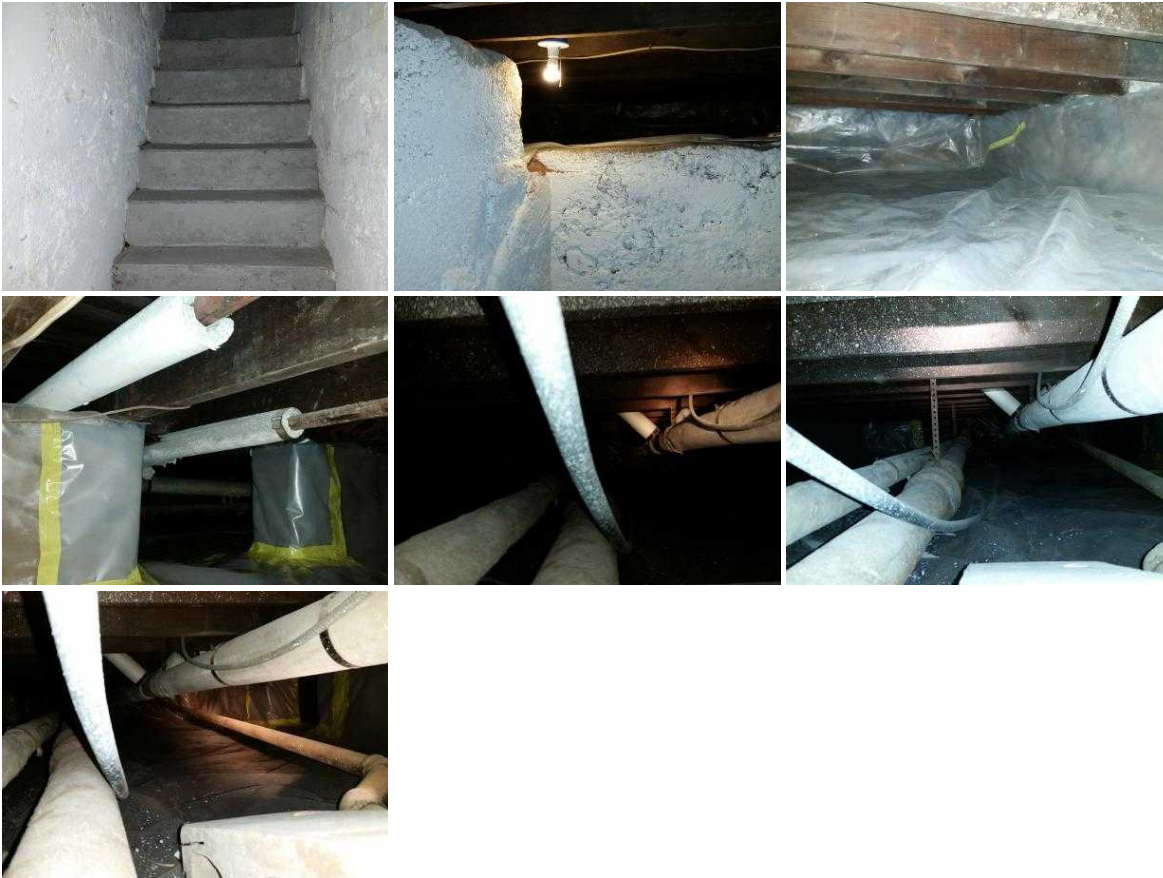
Insulation: None  
Vapor Barrier: Crawlspace  
Foundation: Masonry  
Floor / Slab: Soil - The crawlspace floor is soil and is covered. The plastic has been applied to the sides of the foundation wall and on the floor, but still the area is in need of ventilation. The crawlspace also has the old style asbestos insulation.

Insulation: What is believed to be asbestos insulation is noted on the components of the heating system. Some areas are in poor condition and should be attended too. Asbestos is a controversial material, and is considered hazardous. Complete information concerning asbestos should be obtained from the NJ DEP at 1-609-984-2193. Methods and recommendations vary depending upon the application, and may change with time as well.

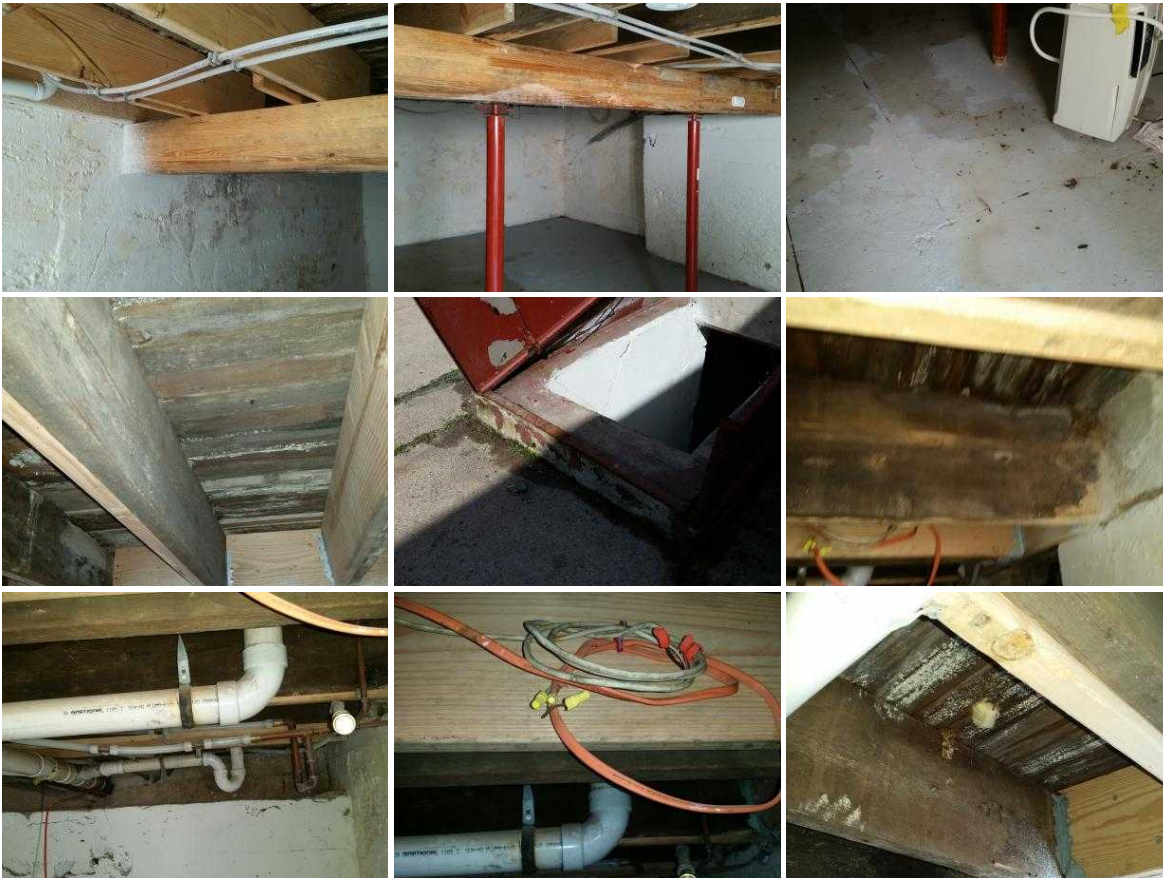
Foundation: Poured - the walls, floor and framing all have some type of water and moisture problem. The basement windows have been covered and the area is very wet and water lying on the floor more than in the other basement.

- Defective Floor / Slab: Painted masonry - water on the floor with an unplugged dehumidifier. The plumbing for the added room has been partially disconnected from the room, but still present in the basement. The pipes are not secure and should be modified.

- Defective Joists / Truss: the original framing has been left in place with newer and added framing, but the old framing still has termite damage and the home will need a full termite treatment.

- Defective Subflooring: the old subflooring has excessive mold and damage and a concern for building and health.
- Defective Posts / Piers: Again, the newly style engineered girder is being supported by temporary posts and they too should be replaced.

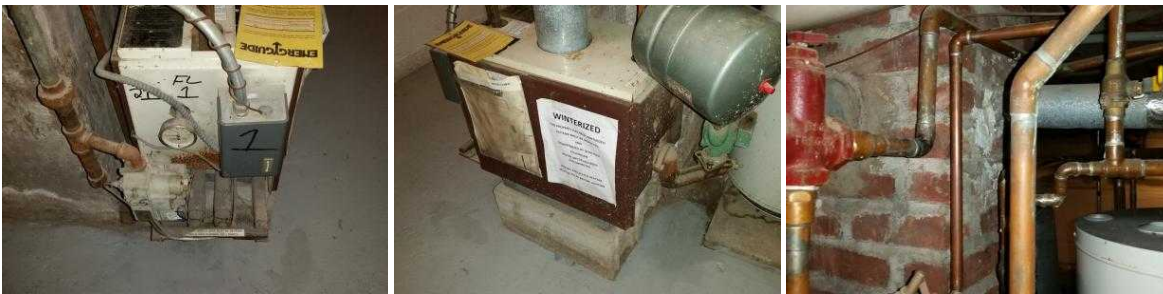
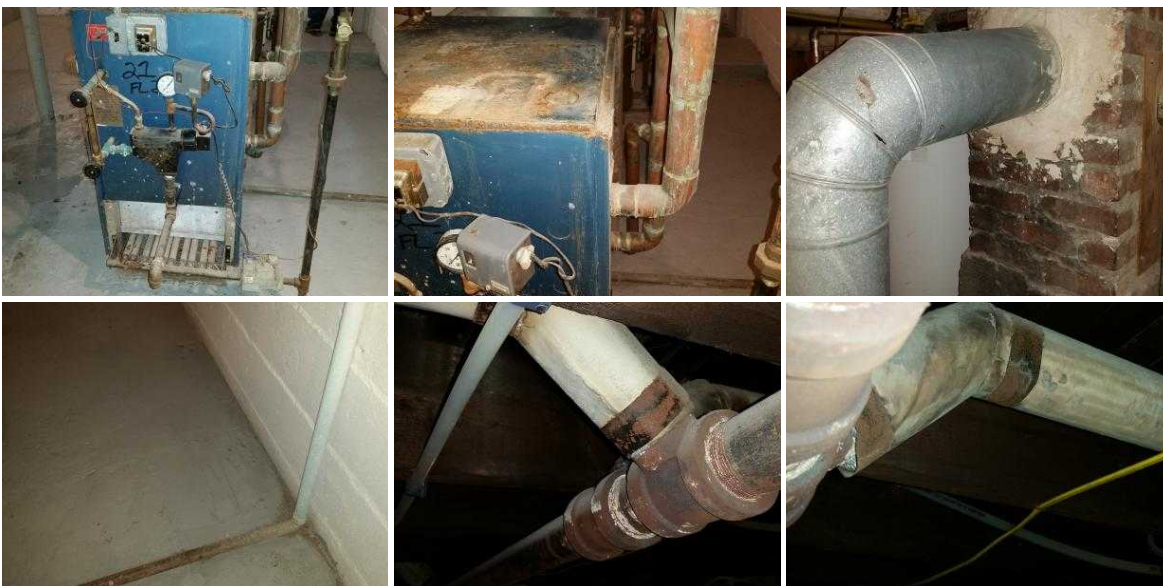
Operation : Not operational and unit appears to be in need of replacement - Heat is provided for the added room by a very old hot water boiler that could not be fired. The boiler piping has been partially disconnected and a sticker on the boiler indicating the system was winterized. The boiler and flue assembly all are in poor condition.

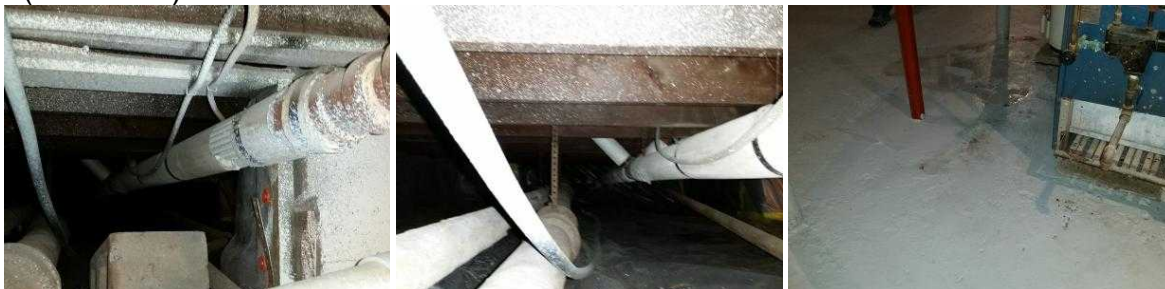
Operation : The unit unit is leaking and showing very poorly and the unit has exceeded its life expectancy and the unit should be expected to be replaced in the very near future. Heat is provided by an old steam boiler and it too has been shut down with no water inside the boiler. The boiler is rusting and corroding and will only worsen because of the water lying on the floor and will only further damage the boiler, cause problems with the flooring and framing and water seep into the home and cane easily cause health problems for tenants. Not all the rooms have a radiators and it too is a concern because every room should have heat and many lenders require heat for every room.

The water level must be maintained within the limits of the sight gage on the unit and the gage appears to be leaking. Water should be drained from the low water cut-off valve periodically to remove sediment and insure reliable operation. It is suggested that hot water be supplied to the boiler because the water will be pre-heated, although a corrosion additive is needed. A steam system requires occasional maintenance to individual radiator shut-off valves and air vents and a heating contractor should make these adjustments. Some of the valves leak over time and the sub flooring tends to deteriorate. A heating contractor should perform a more thorough evaluation of the boiler and its piping system. The normal life expectancy for a boiler is in the vicinity of 25 years prior to the need for replacement.

Distribution: Radiator - The majority of the steam pipes are in insulated with what appears to be asbestos. The steam pipes in the basement should be re-insulated to help distribute the vapors into the radiators. No electrical cords should not come in contact with heating units. The heat will dryout the cord and can cause a short. There are a few missing radiators in the room that will be necessary.

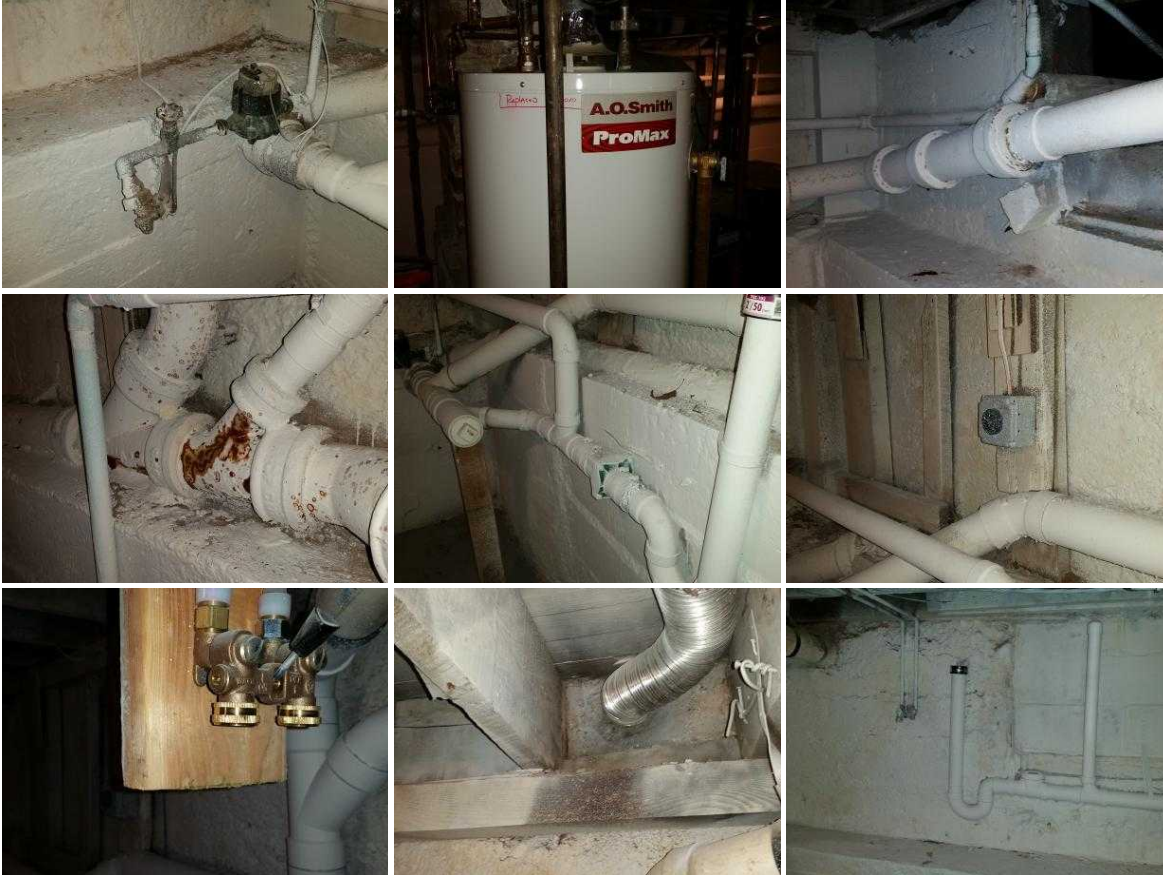
Main Material: Lead - The two buildings have a single water meter with the two building have three gas meters and four electric meters. The house service main run from the exterior or street to the water meter appears to be lead. The water supply in the home may also contain lead pipes and solder. Lead piping was used many years ago and is not a recommended material. It is recommended that the water line be replaced and modified. It is highly recommended that the authorities be consulted about the system and if there are modification and renovations that should be performed.

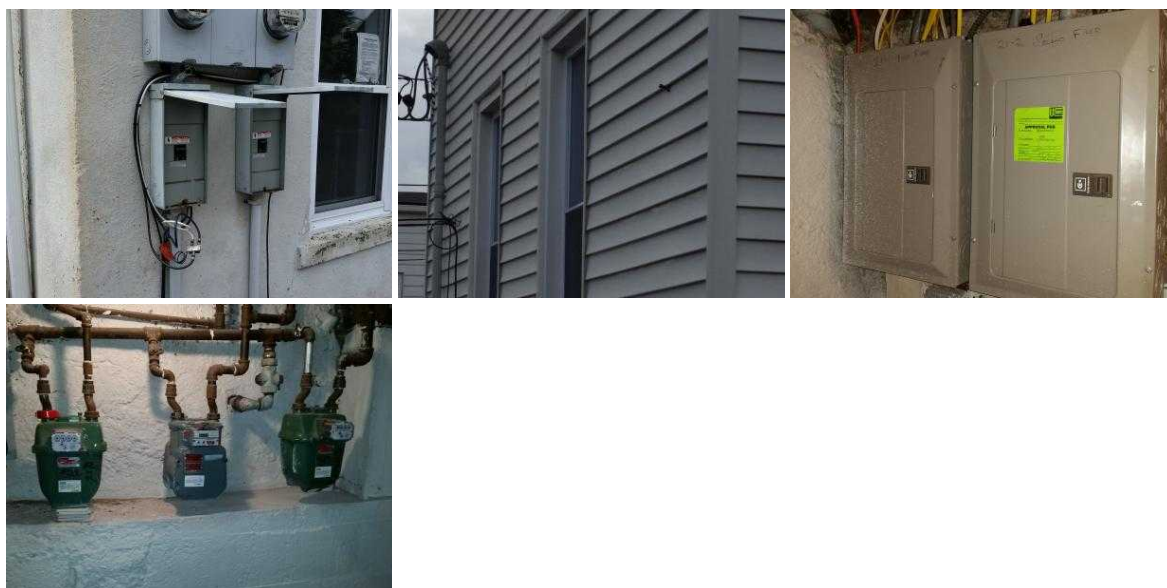
Acceptable      Serviceline: Overhead conduit  
 Main Disconnect: Yes The two main disconnects are located outside at the electric meters because the two main panels are located a distance from the meter, thus required. The main disconnect switches were not operated.
