Home Inspection Report

██████████ Rear Building
Garfield , New Jersey 07026

Report Number : 07-8678

Inspection Date: July 14 , 2015
Time : 4:00 PM

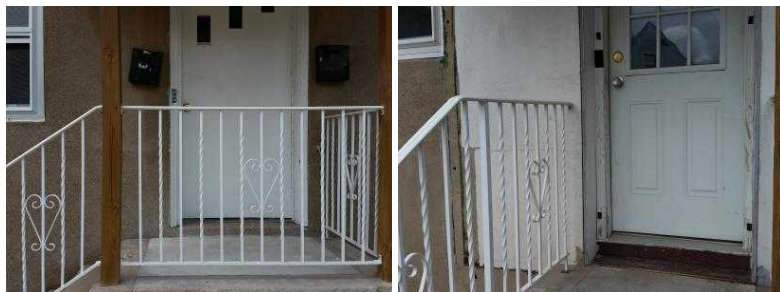
Walks/Entrance

Marginal Front Walkway: Wood - Cracked and pitched towards the building.
 Marginal Front Entrance: Masonry - The steps are not evenly spaced and are too high. The supporting posts for the awning are improperly installed, supports bowing, and twisting and fasteners should be considered. The handrail is also detached and not secured.

Marginal Utility Entrance: Masonry - Cracking skim coat.
 Marginal Walkway: Masonry - Cracking and deteriorating.

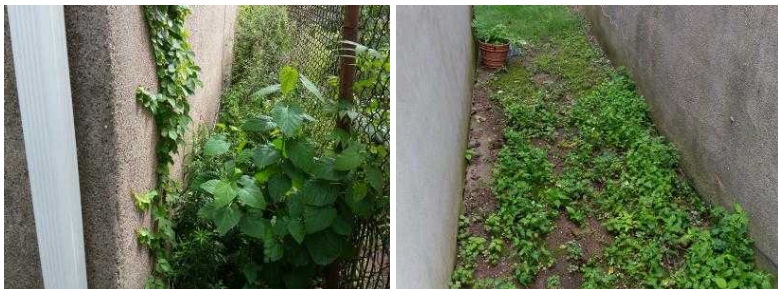
Grading

Defective	Landscaping: Add topsoil, mulch and shrubs - the building is only a few inches off the rear and the vegetation at the foundation is overgrown. The vines growing on the home and chimney is not recommended because they tend to breed insects and can easily damage the siding and vines enter the wall cavities.
Not Inspected	Hose Bibs: Gate - Valves are not operated as part of this inspection, any reference to any valve inspected is visual only unless otherwise noted.
Marginal	Fences: Chain link - The spikes are upward and pose a safety concern.

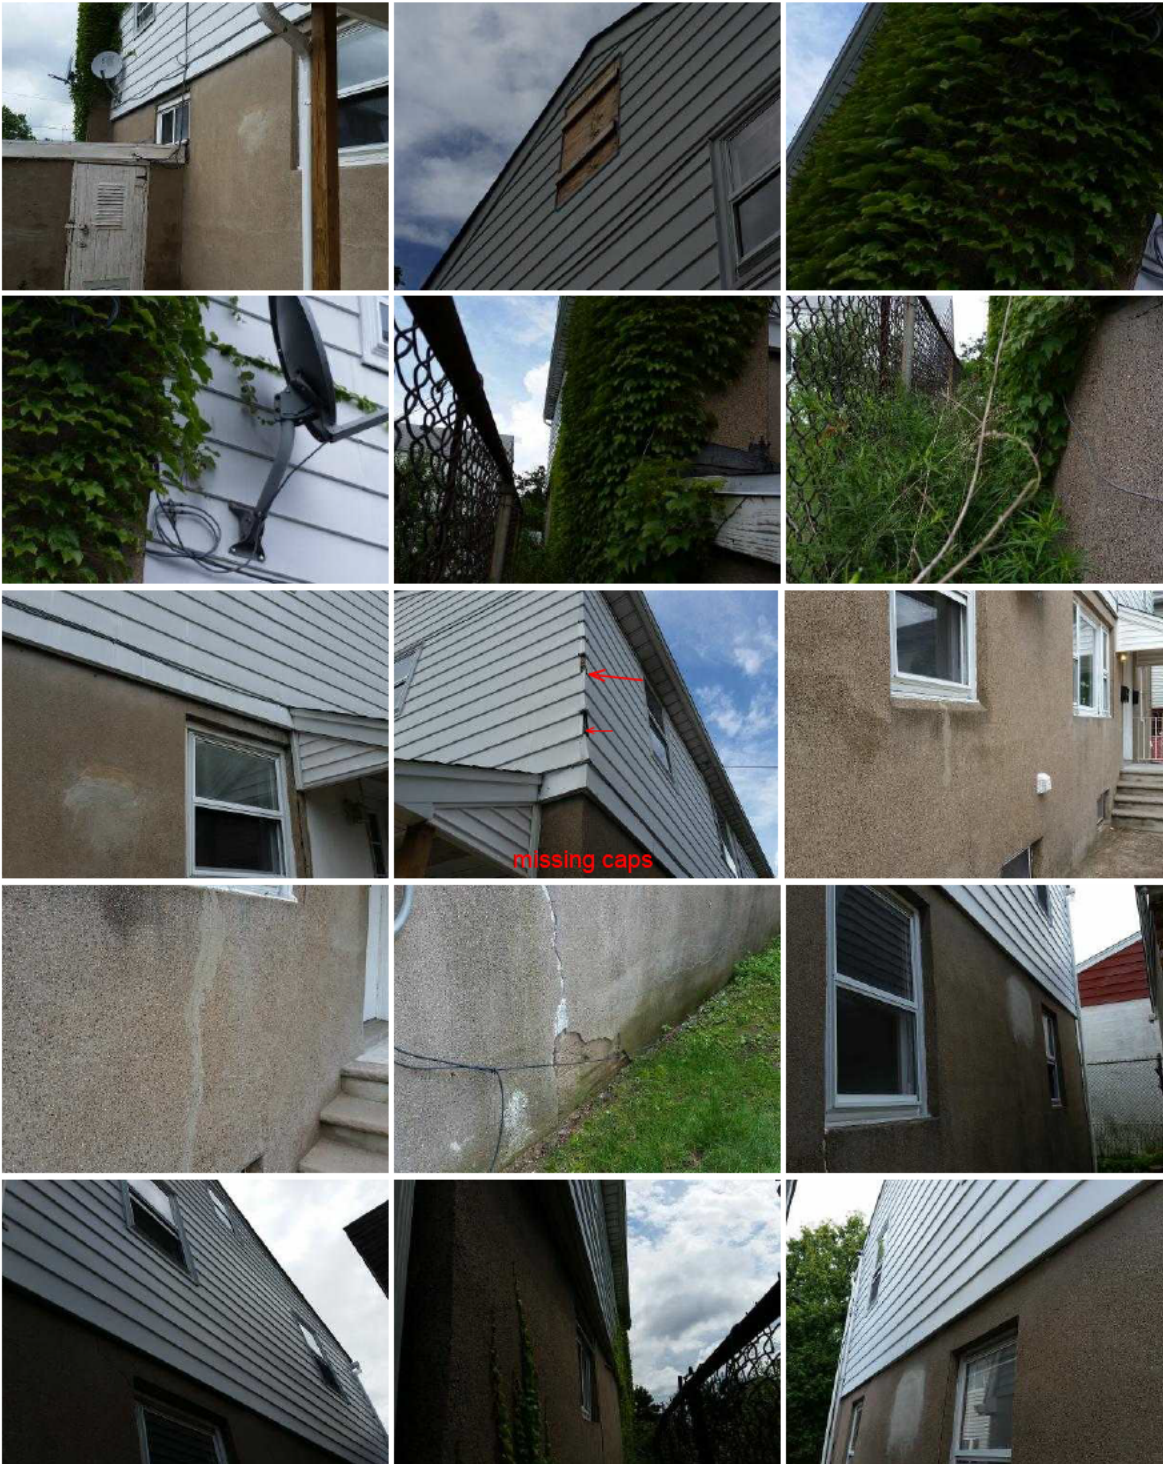
Siding

Material: Aluminum siding - The aluminum siding is durable, and will last indefinitely given regular attention. A variety of metal sidings are available. The most common materials are aluminum and steel. Aluminum siding is used more frequently. Most problems associated with metal sidings are quality and installation. The siding usually have a baked-enamel or vinyl finish, however, the lower quality or older sidings tend to fade and chalk. The siding is also missing corner caps that is allowing water to seep into the building.

The left side attic window has been covered with plywood and shows very poorly. Material: Stucco - The plaster coat siding is in need of a new skim coat. The right side as what appears to be the original garage structure and the corner section is exposed and will need to be sealed. There are also quite a few stress cracks noted in the siding and they too will need to be refinished to help prevent water from entering the home and cause water problems.

The skim coat is cracking and missing in a few locations.

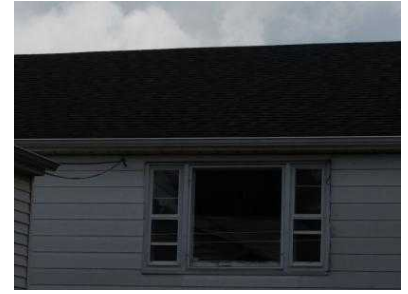
Roof

Material: Dimensional style - The roof is composed of asphalt shingles that are made by impregnating mats of either organic felt material or fiberglass. The shingles appear to be relatively new and a warranty of the roof may be available. The owner will need to be asked about this matter and the roof for the main house.

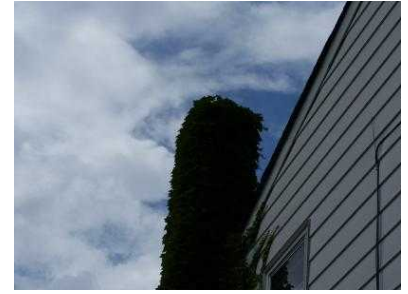
Chimney

Marginal	Material: Masonry - The masonry chimney could not be inspected due to vegetation growth on the siding. This growth is causing excess moisture and the skim coat appears to be cracking.
Defective	Flue/Flue Cap: No cap.
Not Inspected	Flashing: Concealed by vegetation - Flashing tar is a temporary remedy and should not be used. The tar traps moisture in the structure of the chimney causing deterioration.

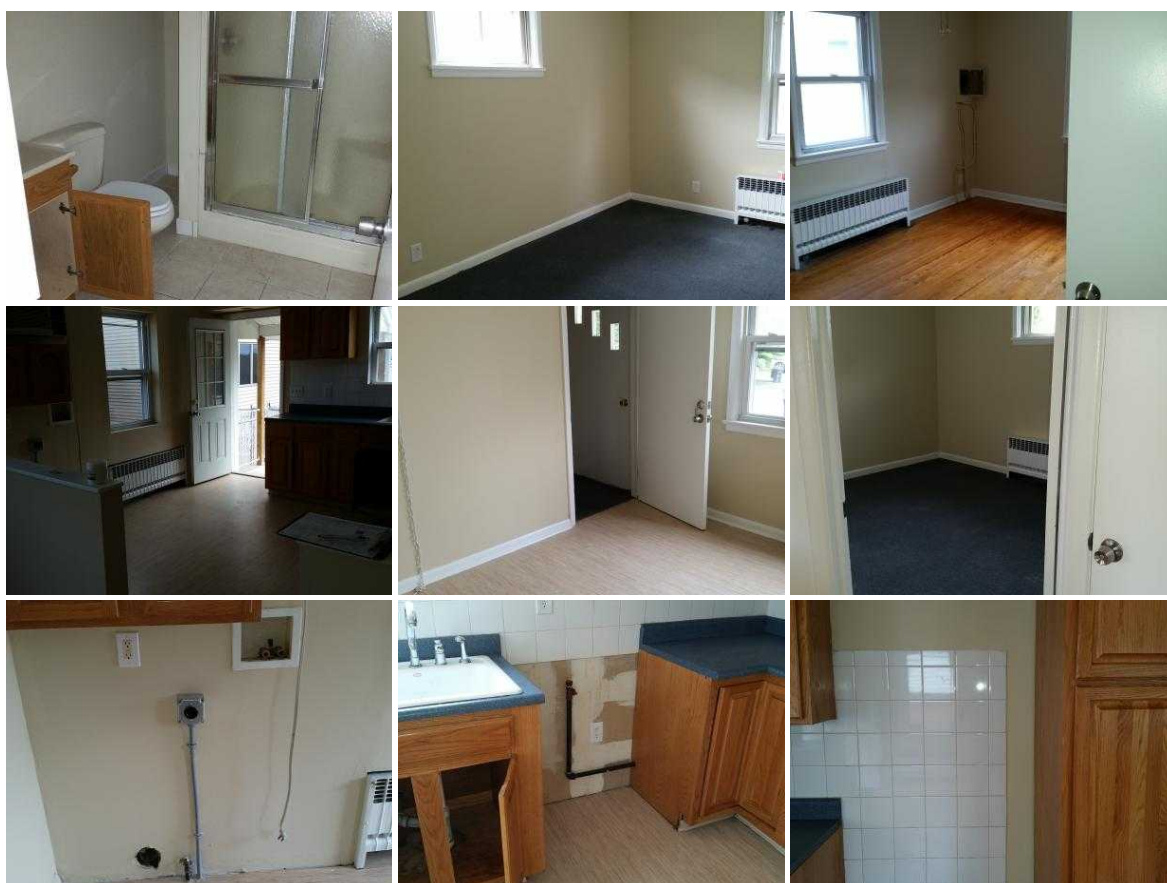
Marginal Acceptable Acceptable Acceptable Marginal Acceptable	Floor: Laminate - Some damages. Walls/Ceiling: Paint Doors: Wood Windows: Double hung, Fixed - Double glazed Electrical: 120 volts - Secure loose outlet box. HVAC: Radiator
--	---

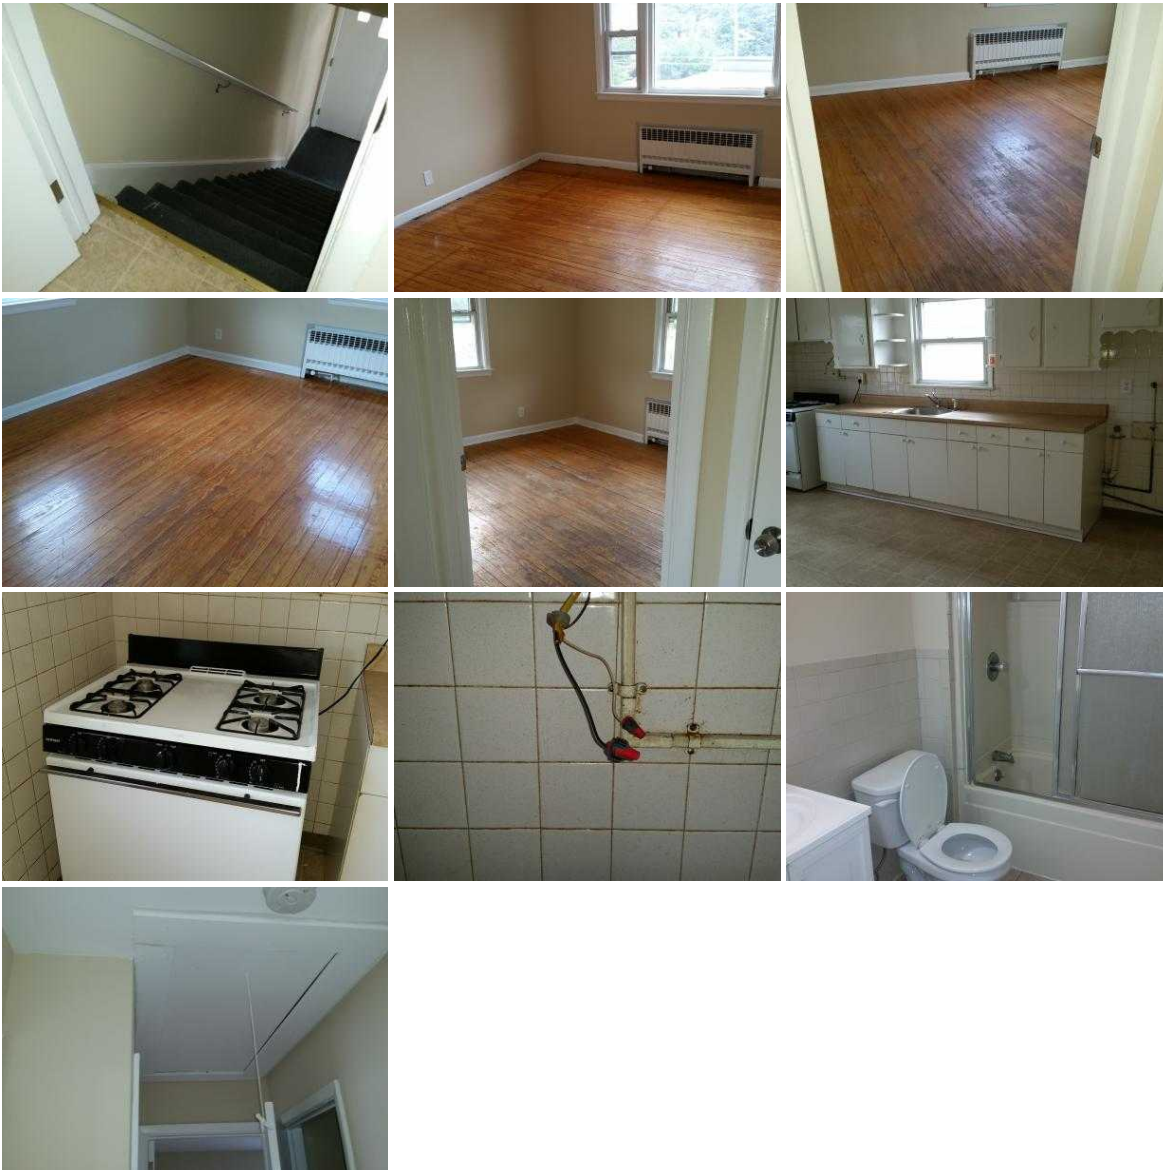
2nd Floor Interior Comments

Marginal	Floor: Wood - Damaged wood floor.
Acceptable	Walls/Ceiling: Paint
Acceptable	Doors: Wood
Acceptable	Windows: Double hung - Double glazed
Defective	Electrical: 120 volts - Not operable.
Acceptable	HVAC: Radiator

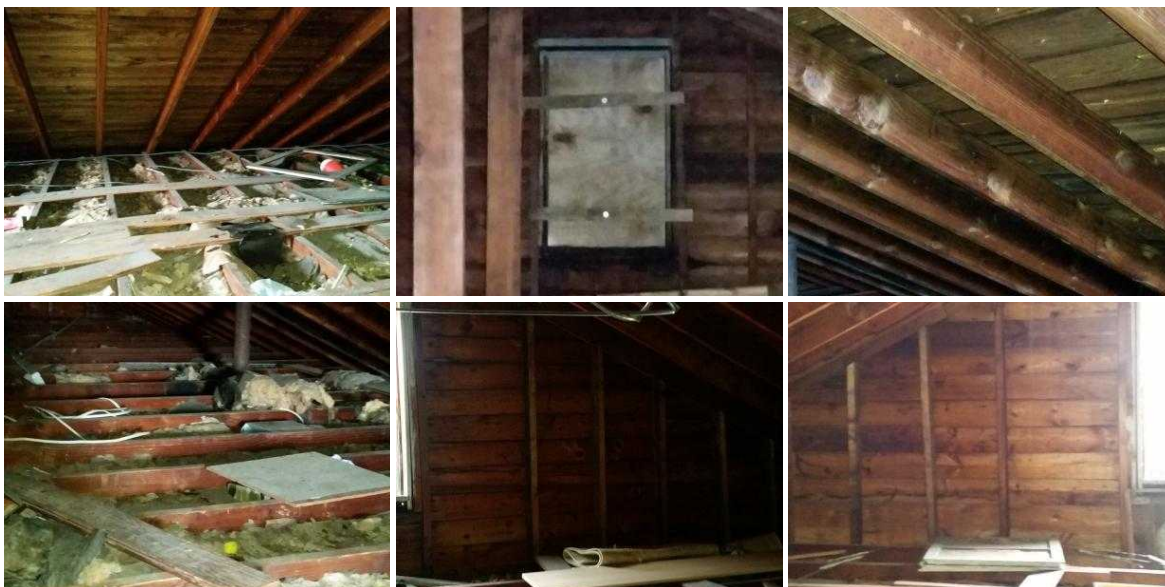
Attic (Continued)

- Marginal Roof Framing: 2x6 - The 2x6 framing is undersized for today's requirements. The attic framing has missing collar ties. These are designed to prevent movement and stiffen the attic roof rafters. The installation of ties is recommended to assure proper roofing support and should be completed by a framing contractor.

- Defective Ventilation: Windows - It is recommended that a power ventilator be installed and equipped with both humidistat and thermostat. The left side window is covered with plywood and the right side has gaps with daylight.

- Defective Water Stains: at chimney and plumbing stacks.
- Defective Insulation: Fiberglass - 1" - 2" of insulation and more insulation recommended. Bathroom exhaust is venting into the attic.

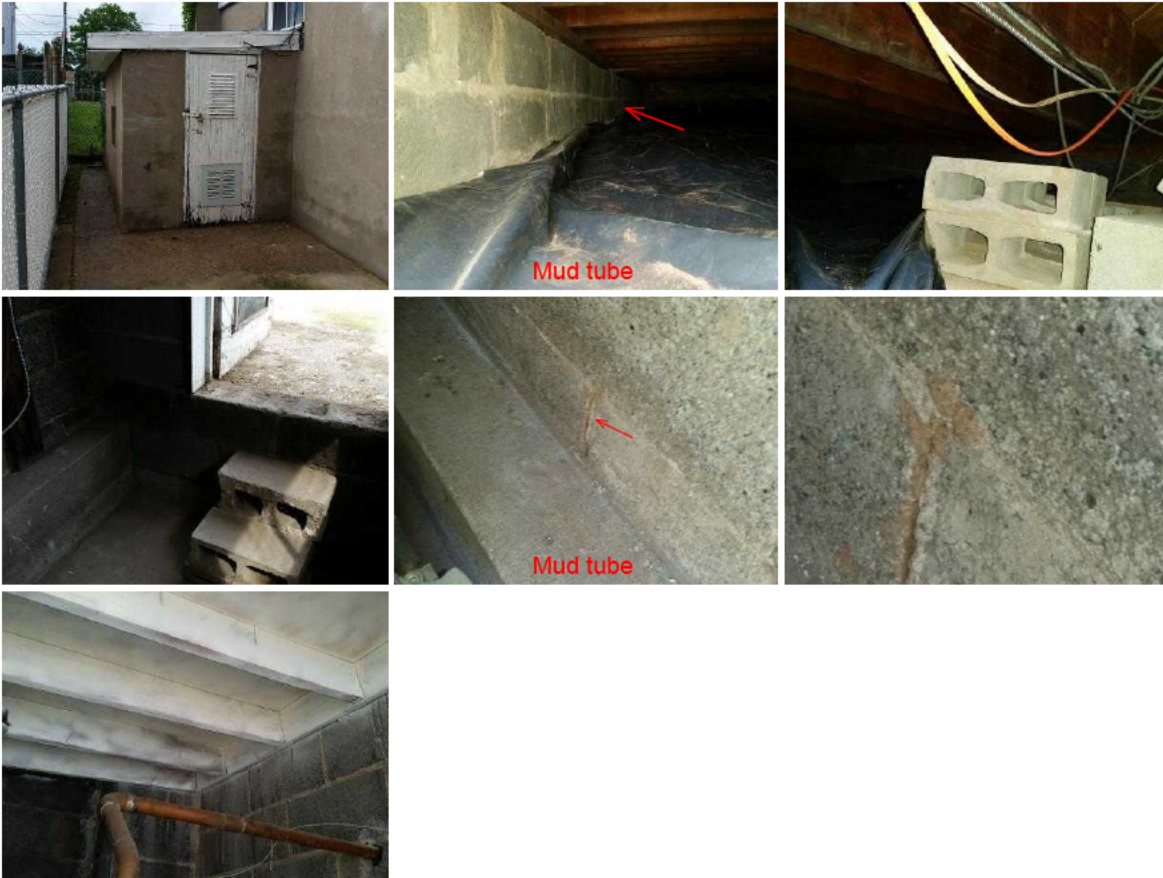
Crawlspaces

Acceptable	Foundation: Masonry block - the three crawlspaces were all viewed by the front windows due to height restrictions.
Defective	Floor: Soil - The floor is soil and not covered. Dampness can be reduced by covering the earth with a vapor barrier such as a 4-6 mil thickness sheet of plastic. Roll roofing is also a good barrier, but tends to deteriorate. To minimize the dampness, the area should be vented. It is recommended that building material be placed on the floor to keep moisture down. It is also recommended that a vapor barrier be placed on the floor joists.
Acceptable Marginal	Joists: 2x10 Subflooring: Boards - , but can develop some type of mold because the soil floor.
Acceptable Water penetration: Yes	Ventilation: Windows - Inadequate ventilation Efflorescence and some stains noted.

Boiler Basement Defective	Doors: Wood - the door is in very poor condition. The small basement or storage room has loose masonry blocks for steps and not very safe.
Acceptable Defective	Foundation: Masonry block Pests: Termites - There are termite shelter tubes noted in the boiler room foundation wall and in the adjoining crawlspace, indicating that this building will also need to be treated for termites.
Acceptable Acceptable	Floor: Masonry Rafters: 2x6 with plywood decking

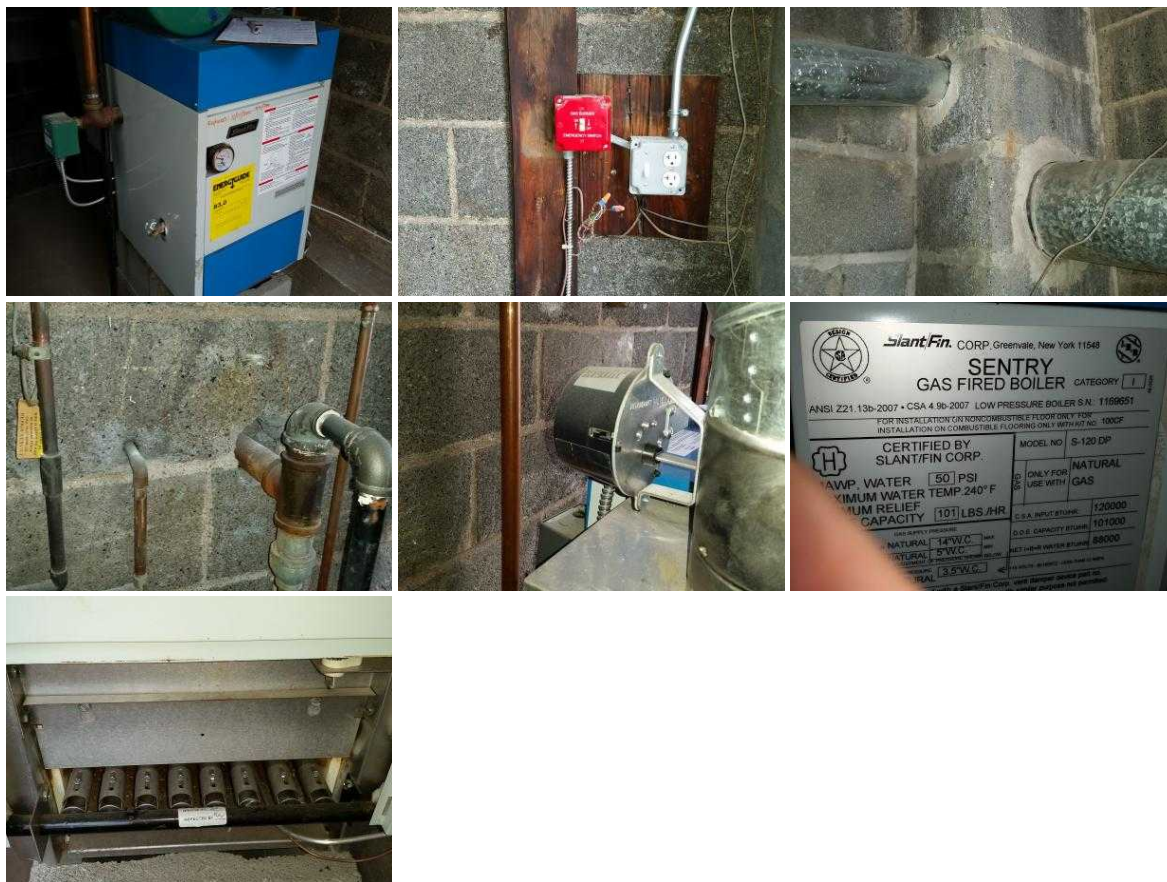
Heating

Operation : The unit is leaking and repairs needed. Heat is provided by a hot water boiler. The burner ignited and operated. Some corrosion was observed, however, it appears to be within normal limits for the age of the unit. The sealant around the flue transition piece should always be well caulked. Operating and safety controls are installed, but not tested. A boiler of this type usually has a life expectancy of about 25 years prior to the need for replacement.

Distribution: Baseboard - No electrical cords should not come in contact with heating units. The heat will dryout the cord and can cause a short. The system is using the old style radiators. The hot water is being used to circulate water trough the system. These radiators can be used for hot water and steam, but will consume more energy and take much longer because of the cast iron material.

The first floor kitchen radiator valve is leaking.

Defective Flue Pipe : Metal - The two flue pipes do not conform to industry standards.

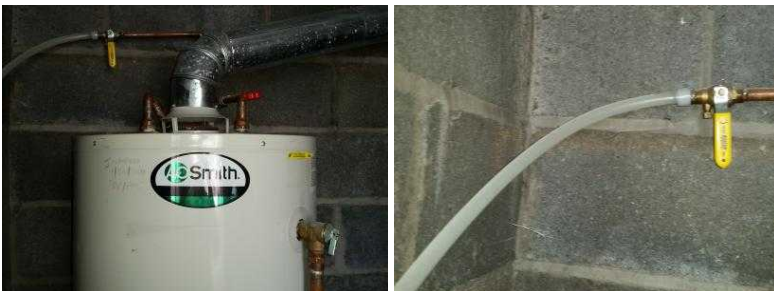
Plumbing

Marginal Main Material: Copper - the water line for the building from the front home was not inspected. The exterior water pipe near the front Bilco doors is a poor arrangement. The pipe routed from the main house to this home is underground and was not inspected nor tested for leaks.

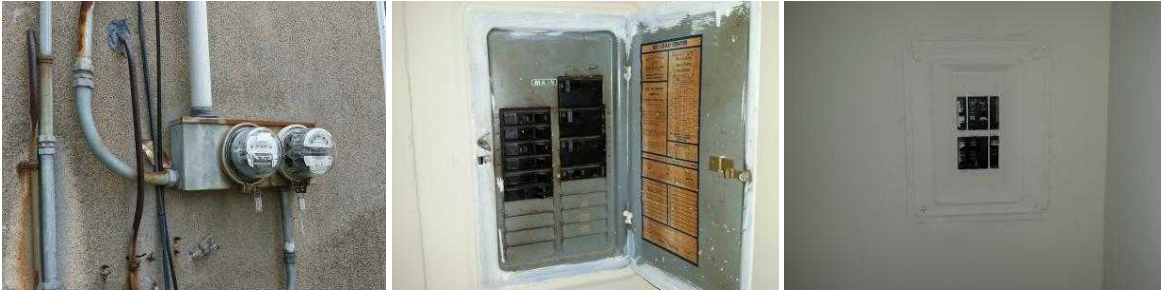
Electrical

Defective **Serviceline: Overhead conduit -** Water is draining onto the two electrical meter pans and is rusting the pans. The overhead lines to the utility pole are touching the gutter system and is not safe.

Acceptable **Manufacturer: Square D**
Main Disconnect: Yes The main disconnect is present, but was not operated.
Amps: 100 **Volts: 240/120**
Defective **Overcurrent: Breakers -** the exposed wires and cables in the room is not safe.
Defective **Ground: Add grounds across hot water tank and exterior.**
Acceptable **Wire Material: Copper -** the panel cover was not removed because it is painted shut.
