Visual Property Inspection

[REDACTED]
North Arlington, NJ 07031

Prepared for :

Sunny Burns

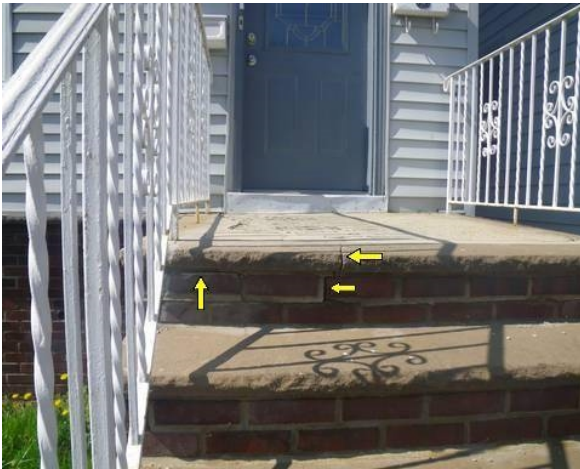
Cracks on front stairway here.

Have a qualified contractor repair cracks in front steps as required to avoid further deterioration.

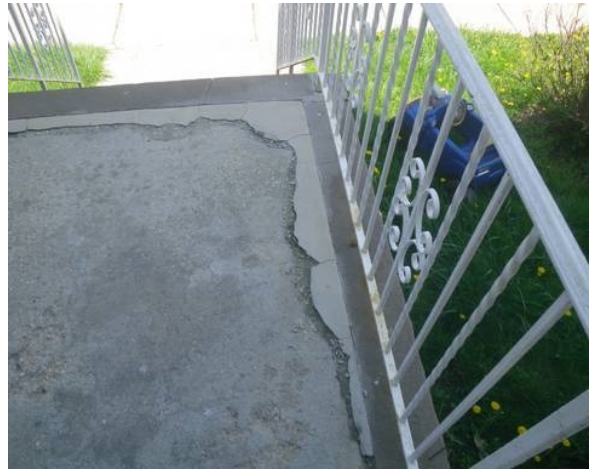
Spalled concrete on front porch deck.

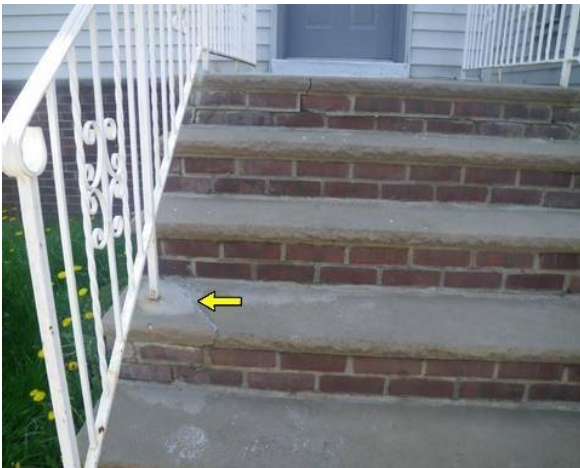
Cracked stone on lower step.

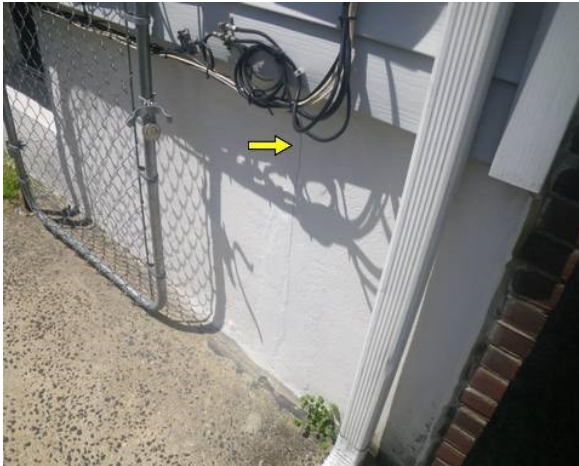
Settlement crack near left front corner of house.

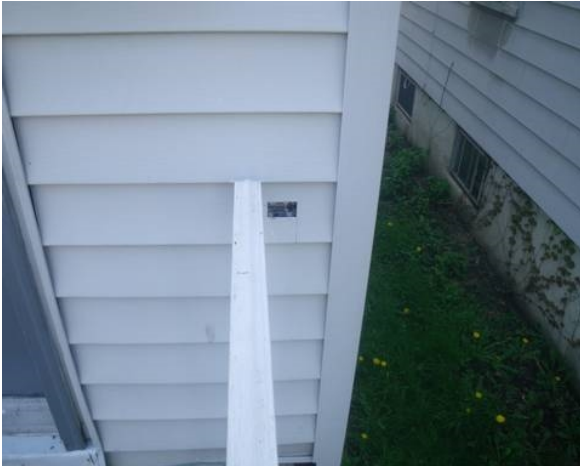
Patch hole in siding.

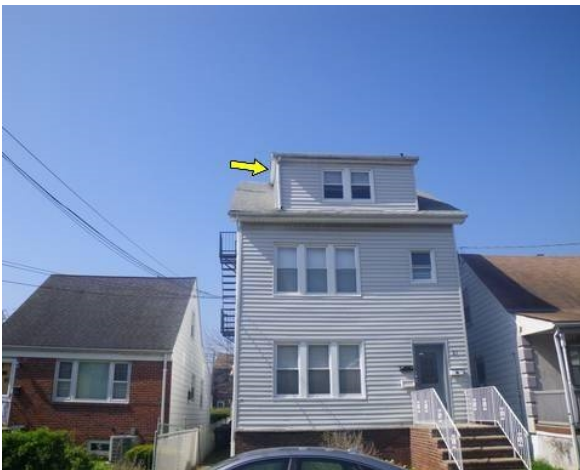
Roofline pitches down here.

Have a qualified contractor replace missing shingles on left side of front roof, evaluate slope of roof inward from edges, evaluate top portion of roof, and make any repairs to roof as required. Also evaluate chimney and repair any loose bricks or other defects as required.

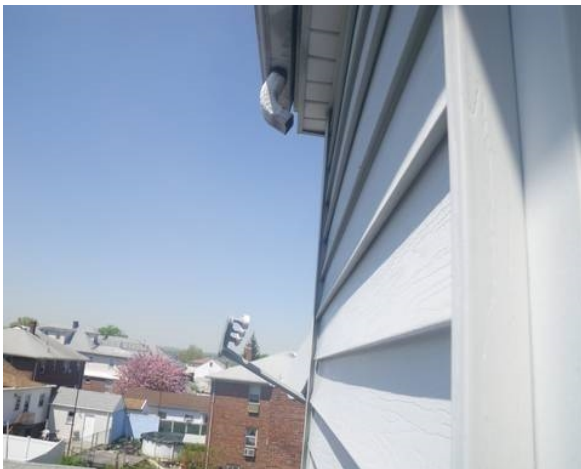
Downspout missing from top back roof.

Clean and maintain gutter system to safely carry rain water away from house. Any above ground downspouts need to extend at least 6' away from house to help keep water out.

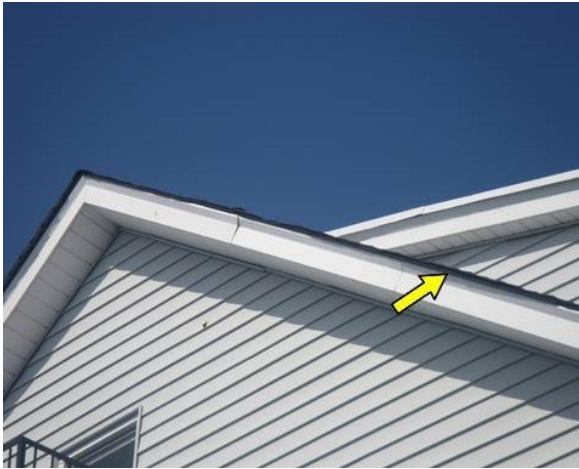
Roof appears to have 2 layers of shingles.

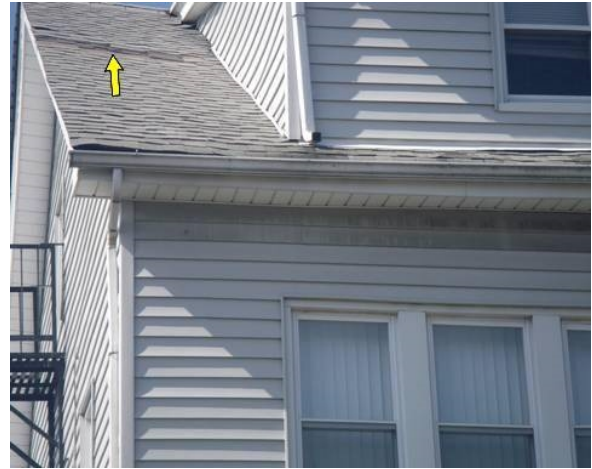
Shingles missing here.

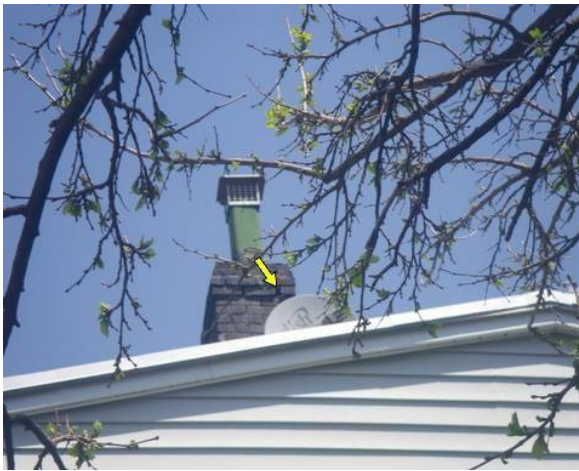
Gaps in chimney bricks can be seen from back yard.

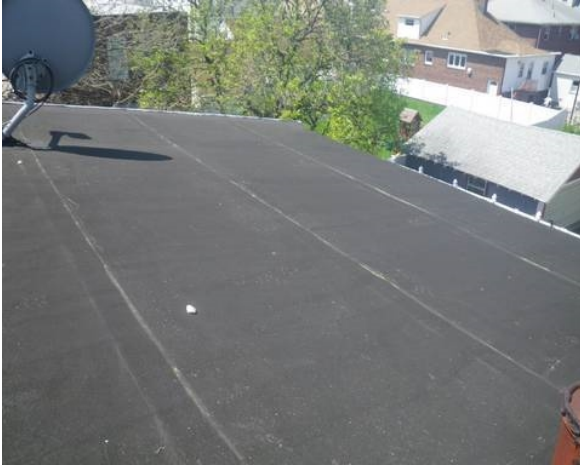
View of back low slope roof.

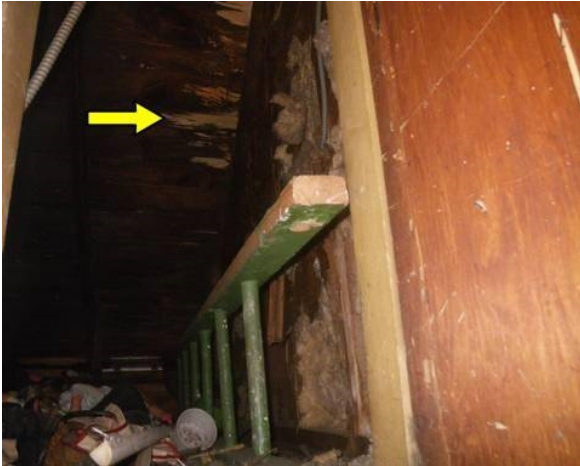
Lower attic had a mold-like growth on sheathing (see picture). Client declined sampling. Mold is a health hazard to mold sensitive people, advise removing any mold for a healthy environment.

Mold-like growth in front lower attic on sheathing.

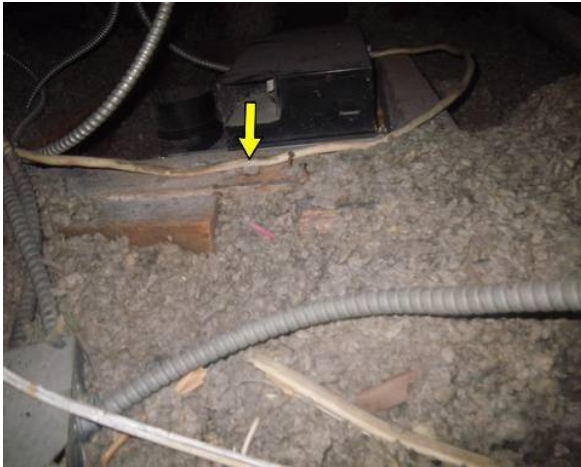
Top unit exhaust fan into attic.

Top bathroom duct vents into attic. Have a qualified contractor extend to exterior to avoid moisture damage.

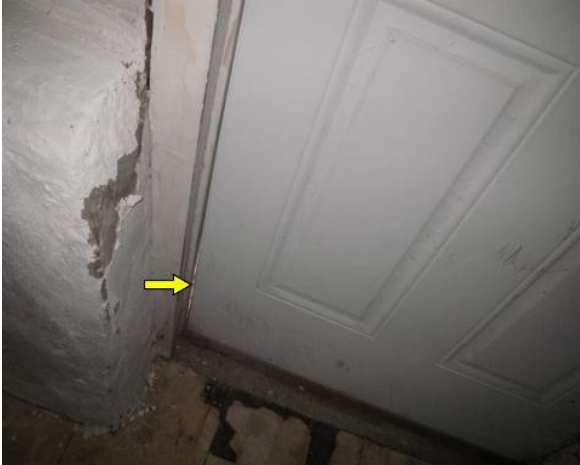
Better seal side basement door.

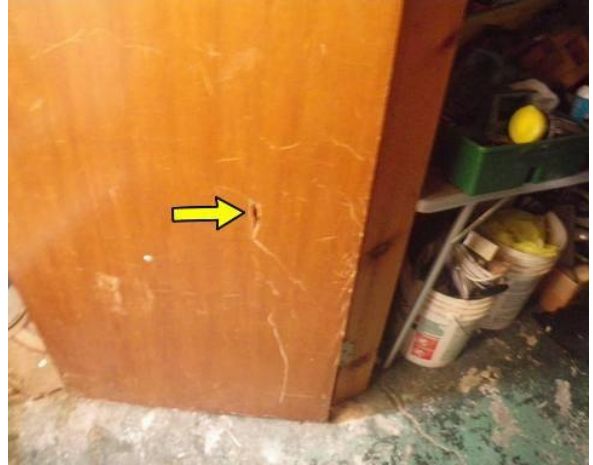
Hole in basement door.

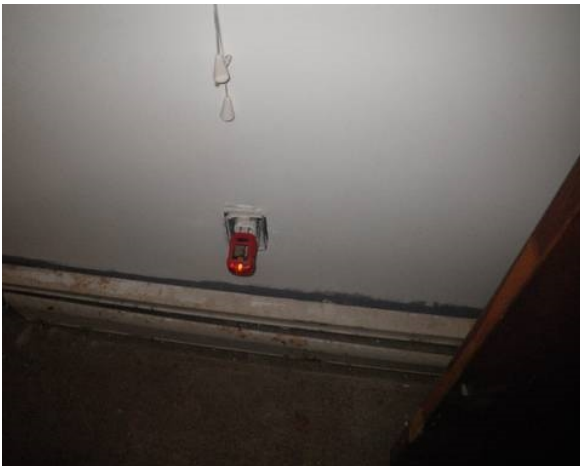
Reversed polarity.

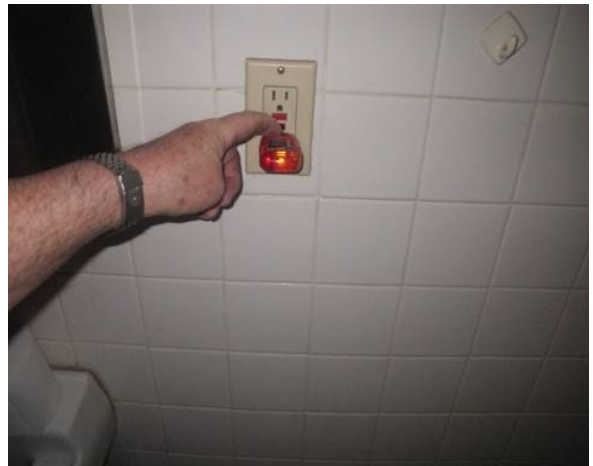
GFCI in bathroom wouldn't turn off.

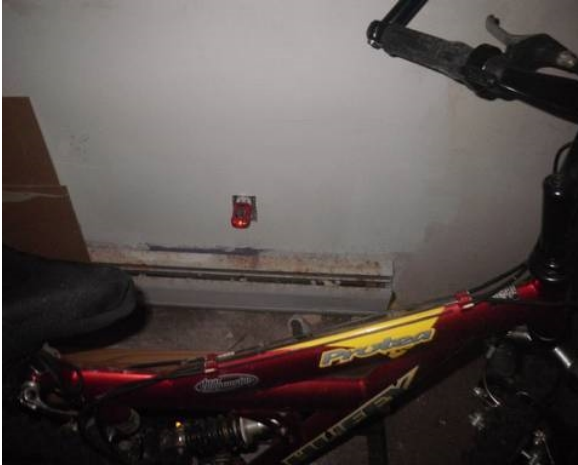
Reversed polarity.

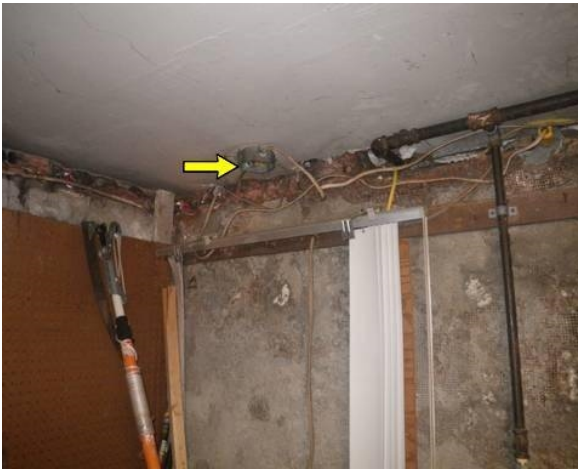
cover open electrical boxes.

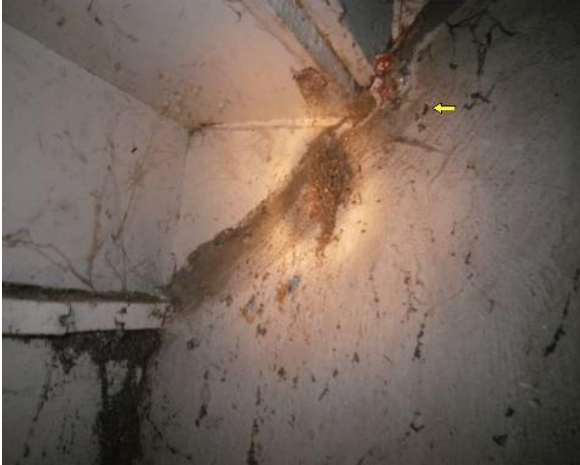
Sawdust and carpenter ant pieces under basement staircase.

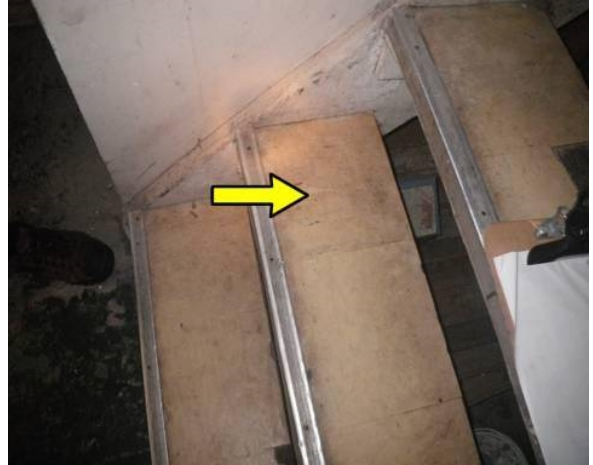
Floor has 9" square floor tiles of age that usually contains asbestos. The only way to know for sure is to test tiles. These are not considered to be dangerous as long as they are not disturbed as the asbestos is encapsulated in the vinyl.

Vinyl tiles on staircase are size and age that typically contain asbestos.

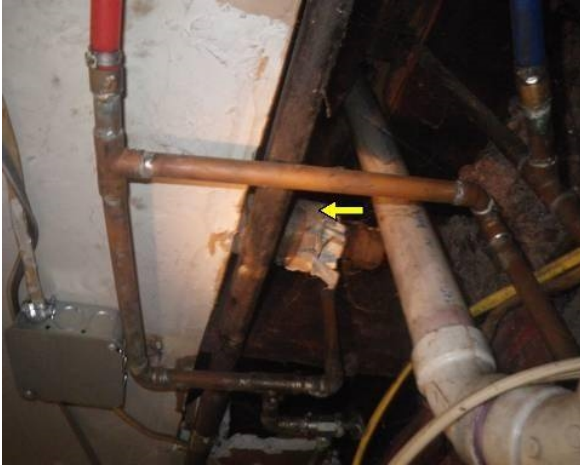
Asbestos like covering on old heating pipe.

Heating pipes have asbestos-like covering (see picture). Asbestos is a recognized environmental hazard. Have any friable asbestos removed or encapsulated by a qualified licensed asbestos abatement contractor for safety.

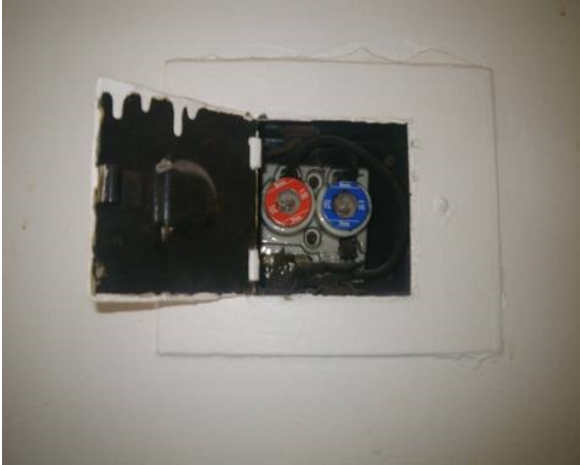
Hallways had fuse boxes in front of each apartment (see picture). These are considered to be obsolete and many municipalities and insurance companies will not accept them at this point in time. Have a qualified licensed electrician evaluate electrical system and make improvements as required for safety. Include repairing reversed polarity outlets and installing GFCIs where needed for safety.

All units had fuse boxes in hallways in front of entrance.

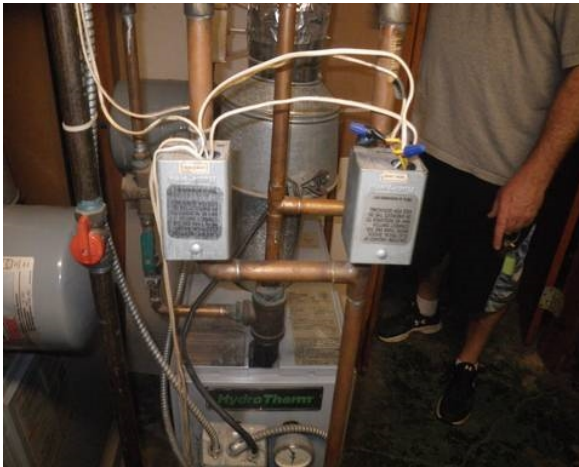
2 zones on first floor boiler.

Heat for basement zone did not come on when tested. Have a qualified licensed plumber make repairs as required for normal function. Have the heating systems serviced and repaired as required prior to settlement by a qualified licensed contractor to ensure proper operation.

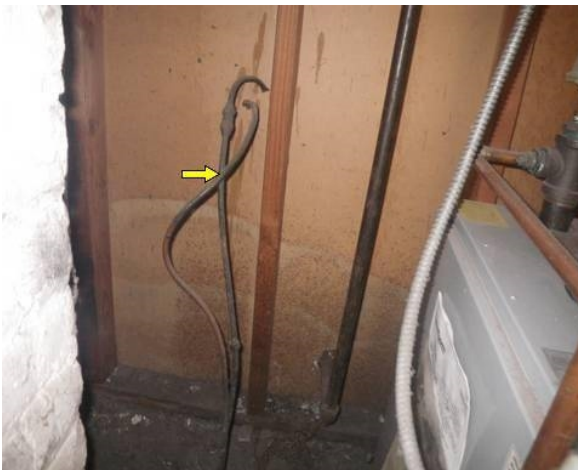
Old oil feed tubes.

Check with seller to see if they have proper paperwork confirming that oil tank on property has been properly de-commisioned.

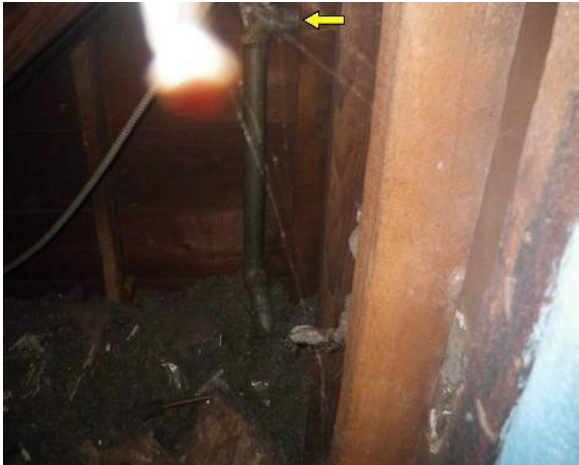
Vent stack pipe in closet has an opening on side.

Have a qualified licensed plumber evaluate vent pipe in back attic which appears to have an opening on side (see picture). Make any repairs as required for safety.

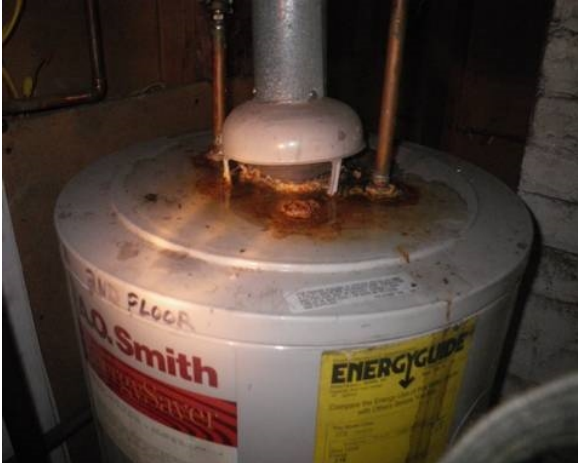
Second floor hot water heater had an active leak.

Hot water heater had water leaking out at top (see picture). Have a qualified licensed plumber repair or replace as required to avoid further water leaks or failure. Also have plumber repair pressure relief valve tube that has come loose and correct downward slope of water heater vent for safety.

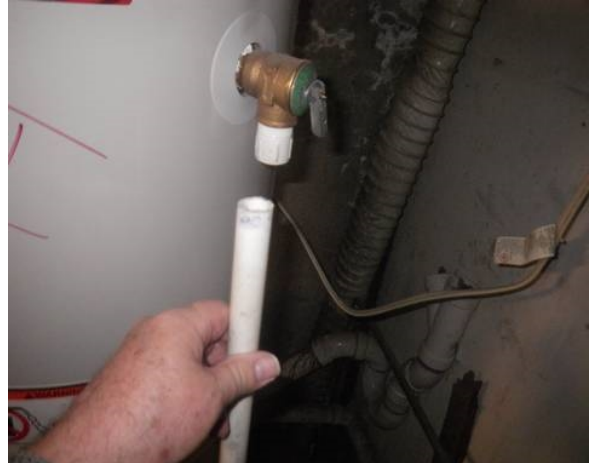
Pressure relief tube fell off hot water heater.

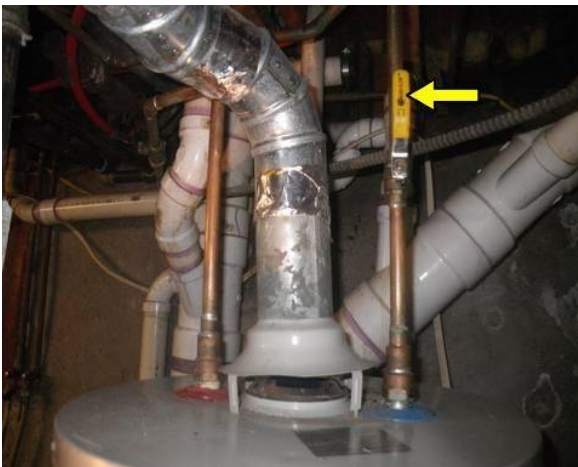
Cold water input shut off valve.

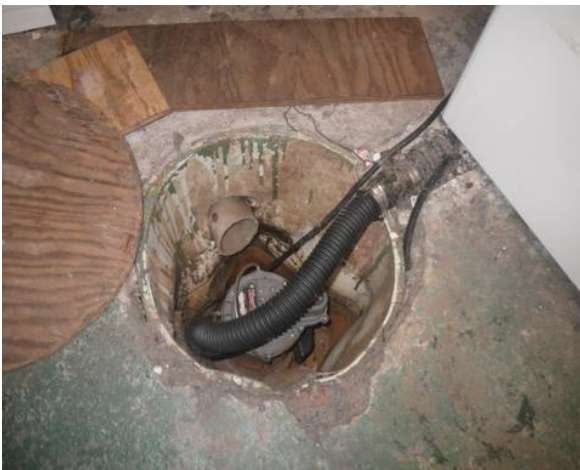
Sump pump in laundry area.

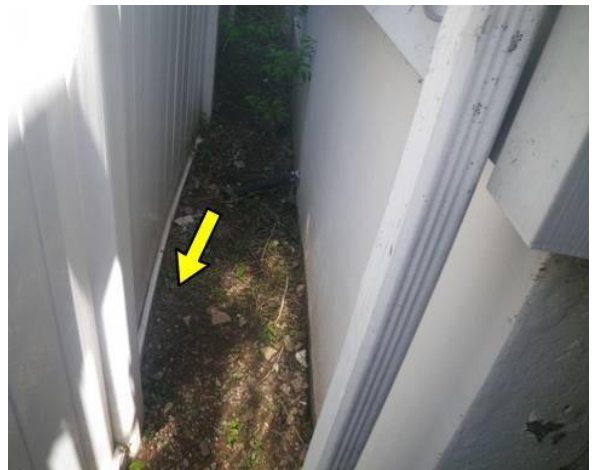
Extend discharge from sump pump further away from foundation wall.

Extend discharge tube further away from foundation.

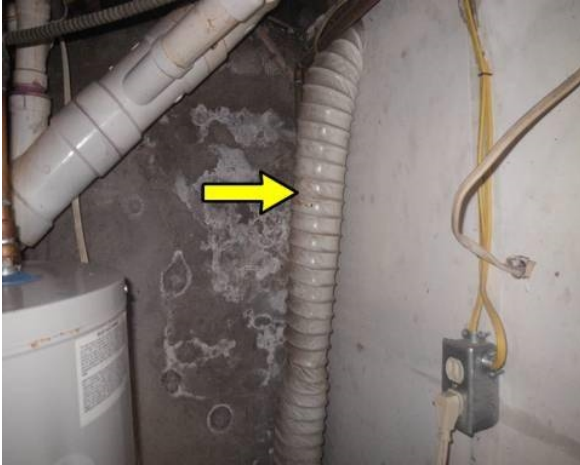
Replace plastic laundry vent for safety.

Replace plastic vent with metallic for fire safety.

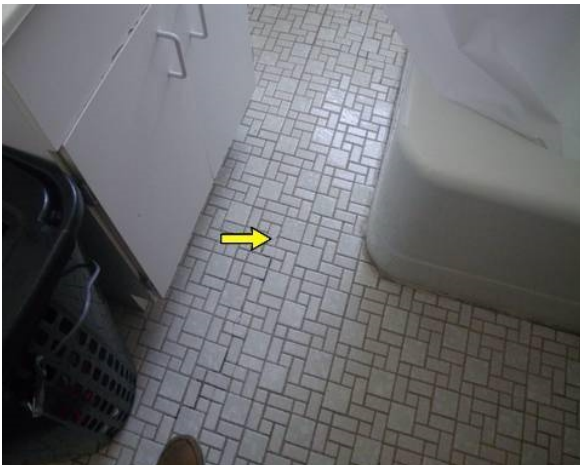
Cracked tiles here.

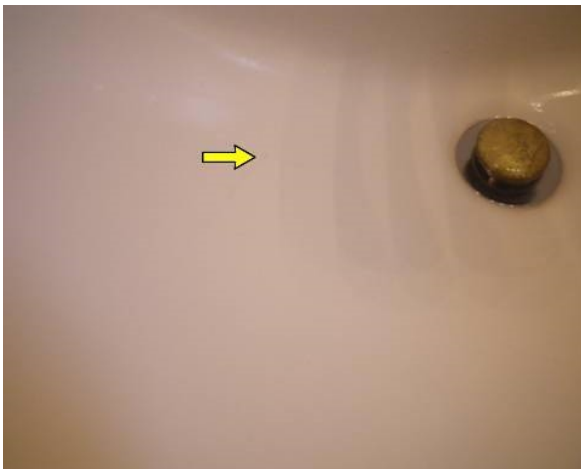
First floor vanity sink has a small crack.

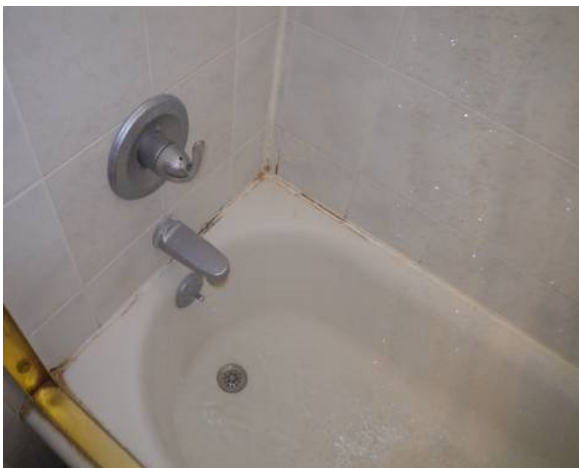
Re-caulk around tub.

Keep tub and shower enclosures caulked and grouted to prevent water infiltration and subsequent damage.

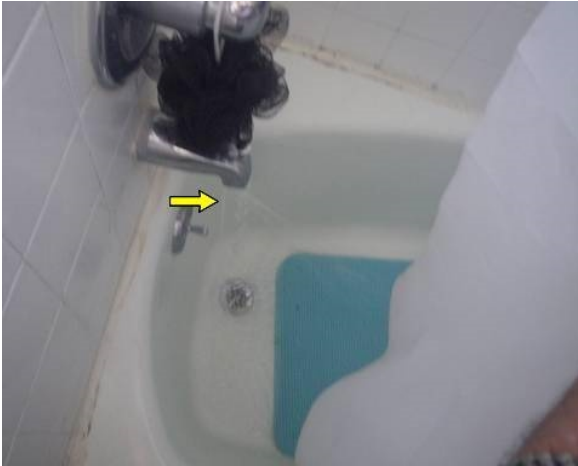
Diverter valve in shower allows water to continue to come out of tub faucet when shower is engaged. Have a qualified licensed plumber repair for normal operation. Also have repair or

Water comes out of faucet when shower is engaged.

replace kitchen wand in basement and kitchen faucet on first floor. Make any other plumbing repairs as required.

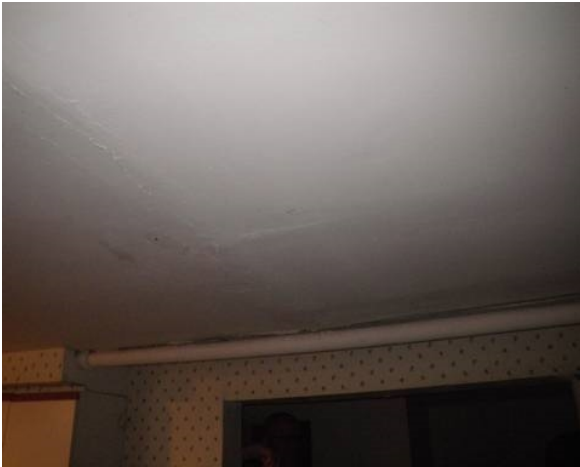
Patched cracks in basement kitchen ceiling.

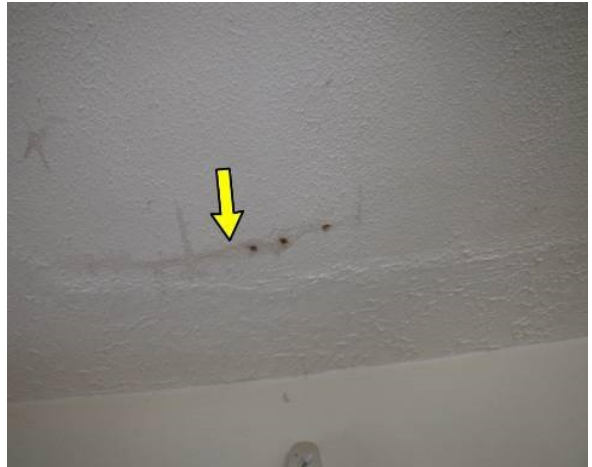
Stain on first floor ceiling and holes tested normal for moisture at time of inspection.

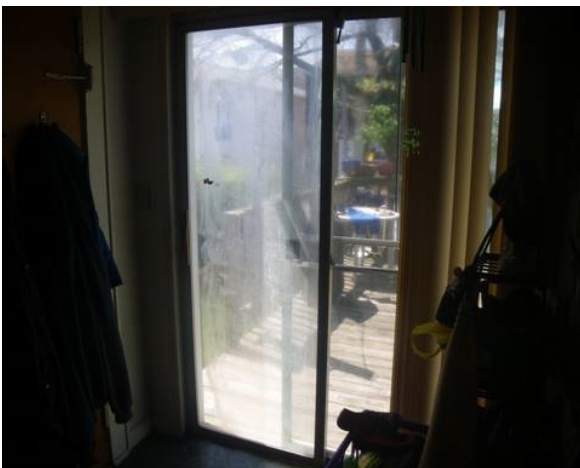
Patio door glass has bad seals.

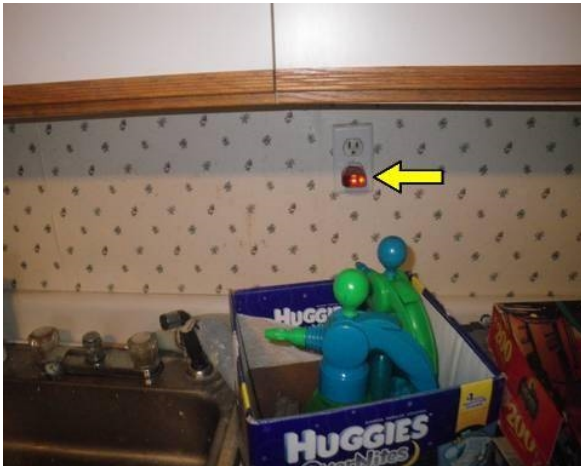
No GFCI near basement kitchen sink.

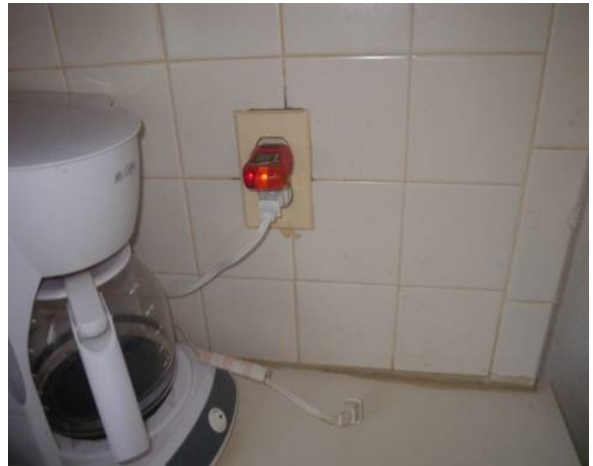
No GFCI reversed polarity on kitchen counter.

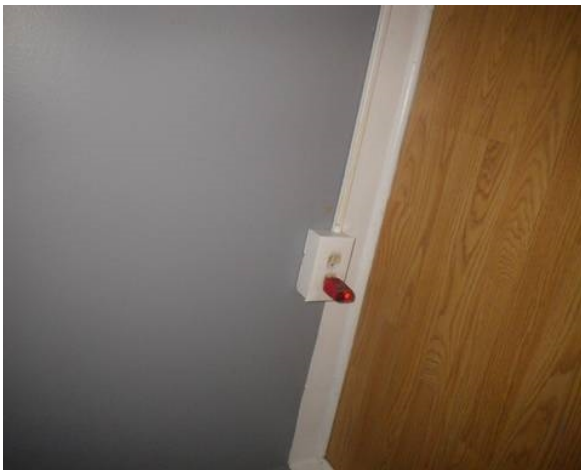
Ungrounded receptacle in upstairs kitchen.

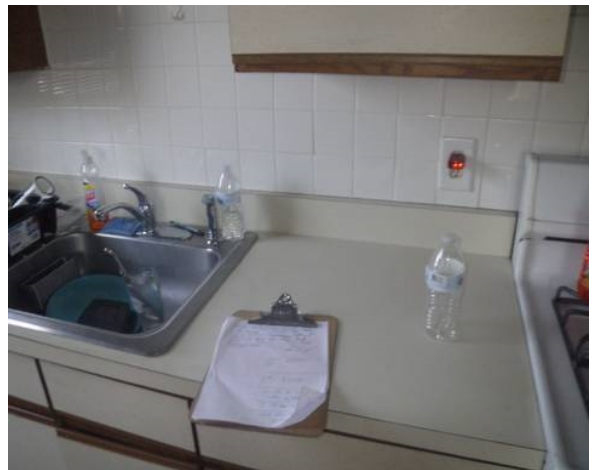
No GFCI in kitchen.

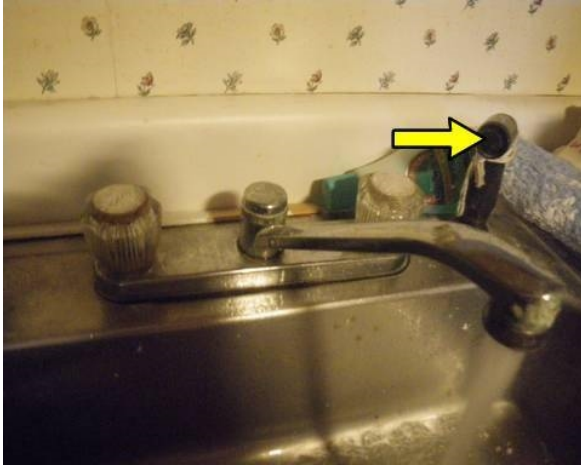
Basement kitchen hose wand is clogged.

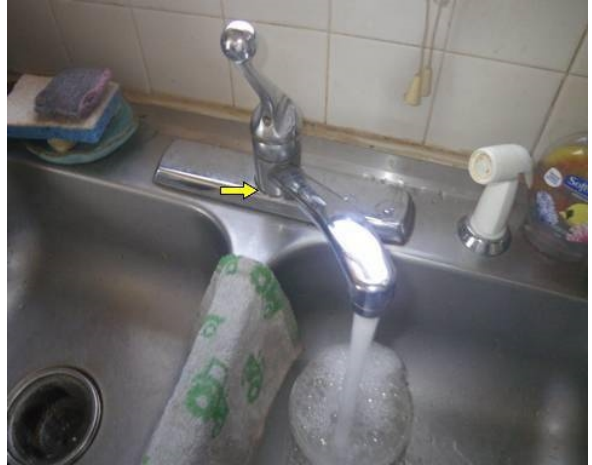
First floor faucet leaked at pivot point.

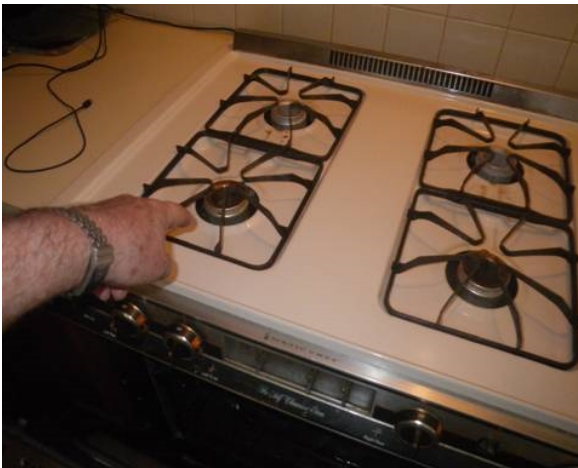
Left front burner wouldn't light.

Left front burner on the first floor gas range does not work. Have repaired by a qualified major appliance repair person for safety.

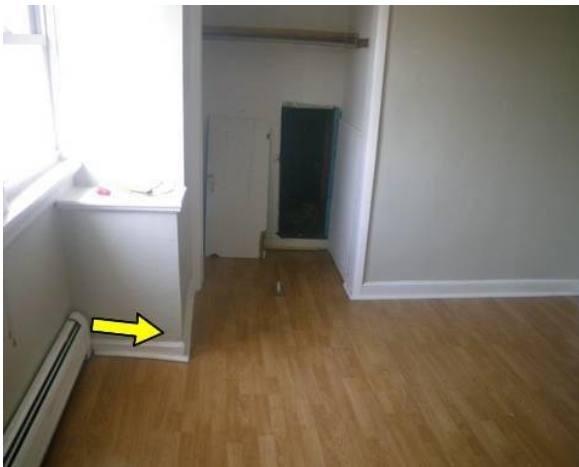
Flooring noted to be sloping in third floor unit (see picture). Sloping floors are common in older building as a result of differential settlement. No obvious evidence to suggest the settlement is ongoing at this time, but only a licensed structural engineer is qualified to evaluate structural issues. Have home evaluated by a qualified licensed structural engineer if you want a definitive opinion on adequacy of the structure. Make any improvements as required.

Some of flooring in top unit is uneven.

Determine extent of floor deterioration replace sections as required to reduce continued deterioration affecting sound areas.

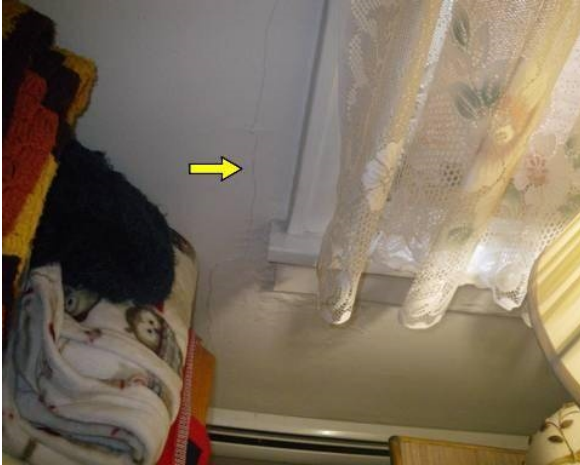
Crack near front windows tested normal for moisture.

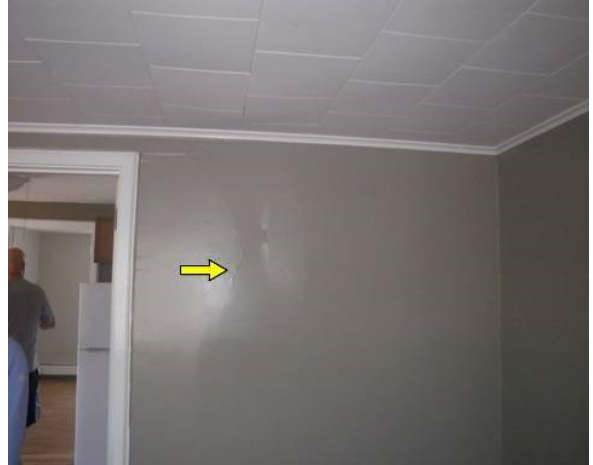
Dent in wall of top unit here.

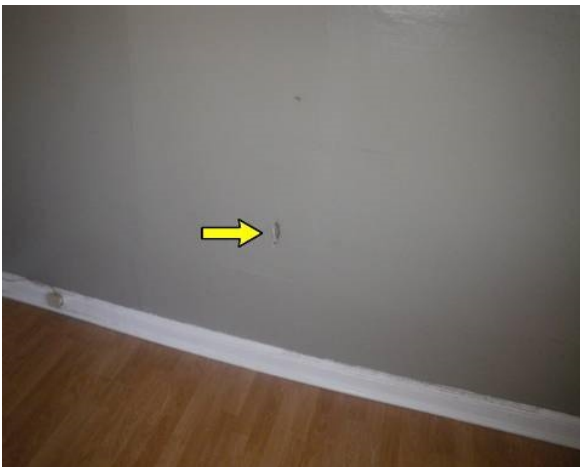
Hole in wall of top unit.

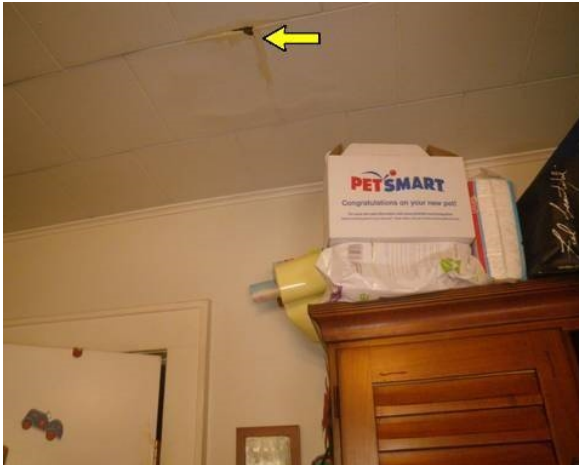
First floor dining room stained tile tested normal for moisture.

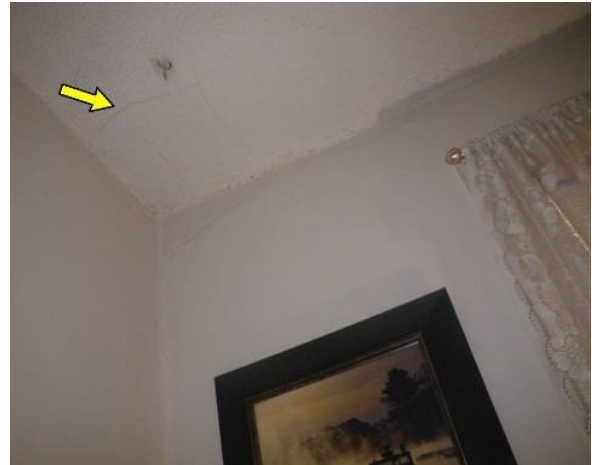
Ceiling cracks in second floor living room.

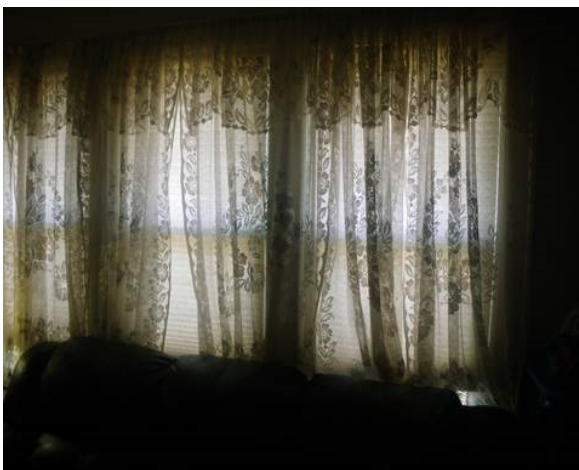
First floor front living room windows slam down if released.

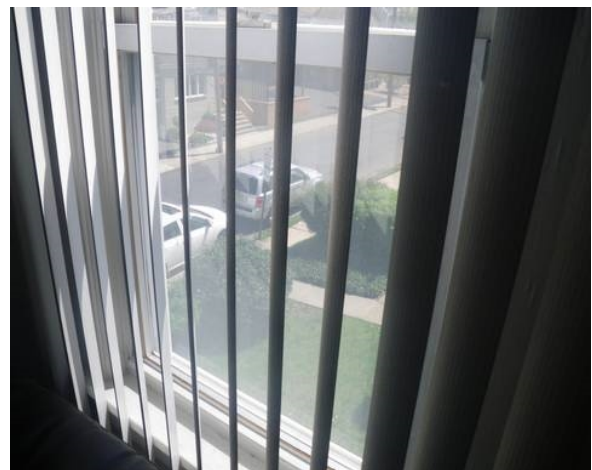
Second floor side window slams if released.

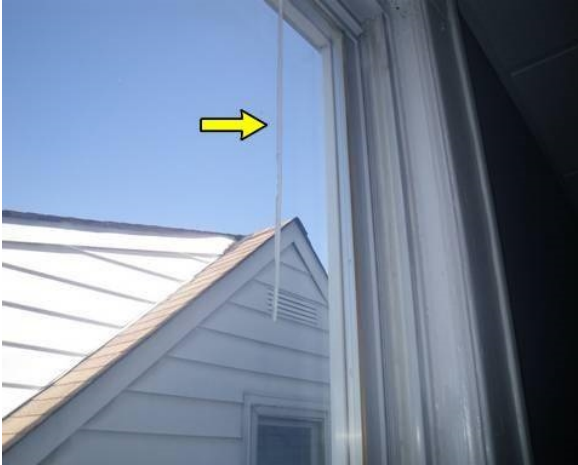
Sealing strip loose from top of side window.

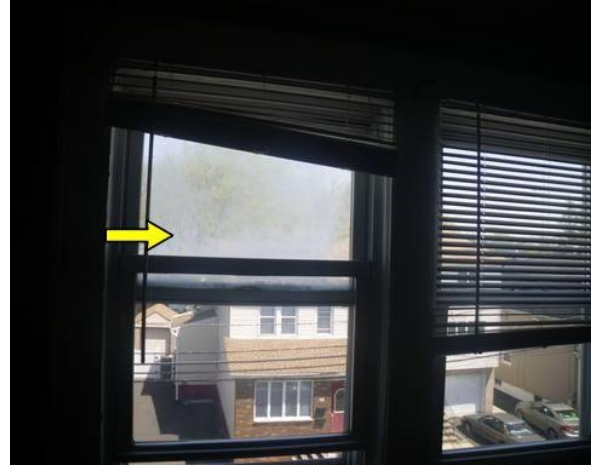
Front top window in top unit has bad seals. The other slams down if released.

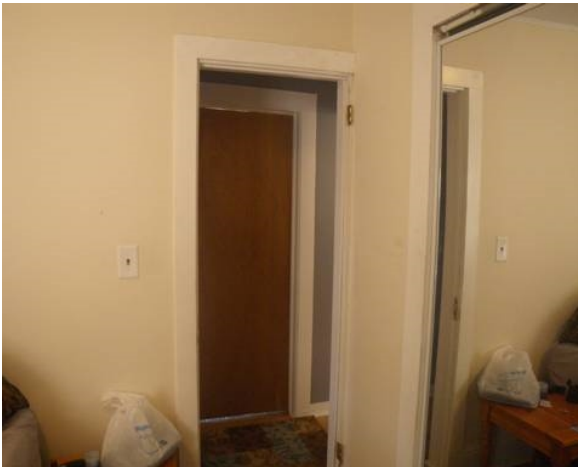
Missing door.

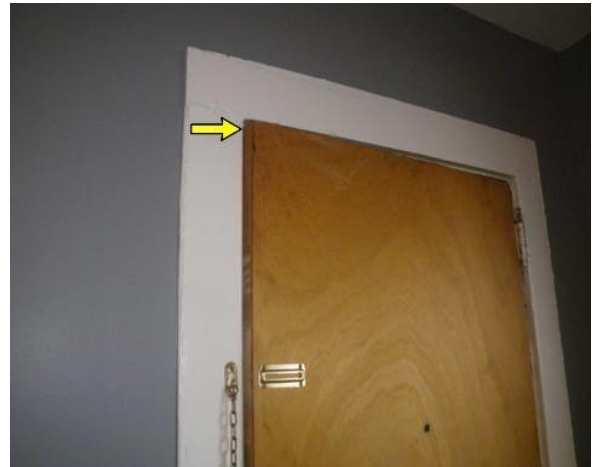
Door binds.

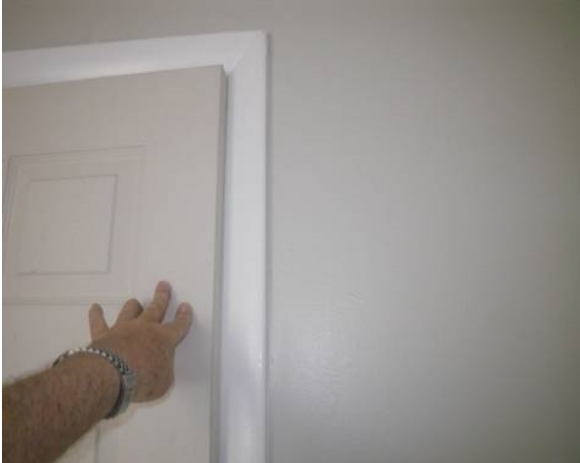
Door binds on top unit.

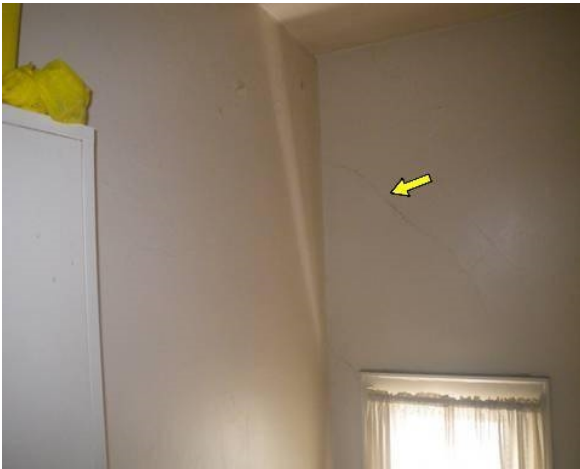
Cracks in back stairway wall.

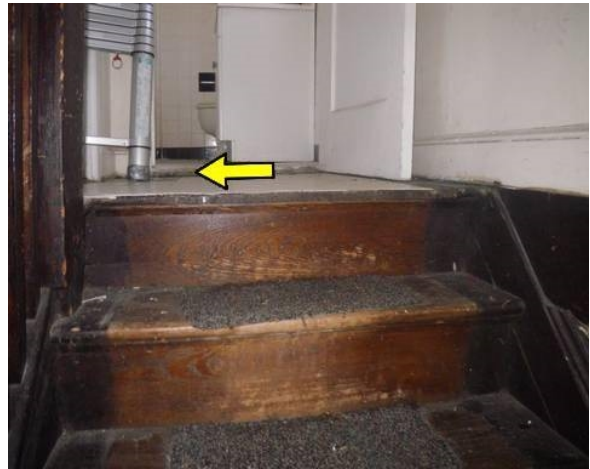
Stairway tilts towards center of building on top floor.
